Henderson Township – Branch Road

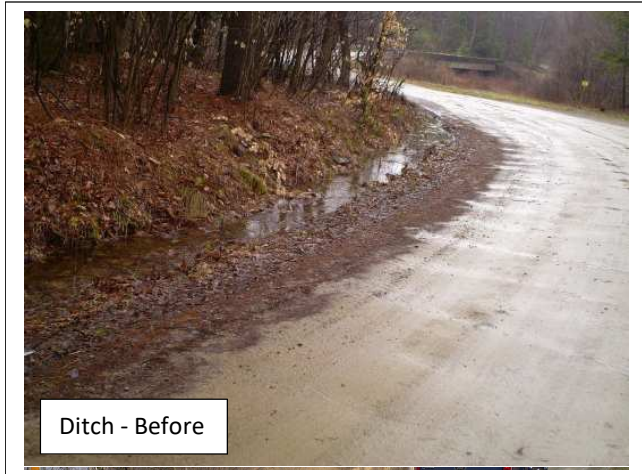
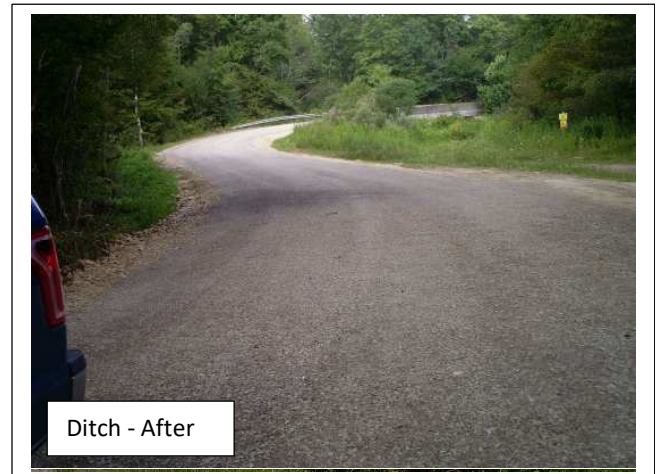
Problem: A road side spring, groundwater and a lack of cross pipes were causing the road base and the road ditch to become saturated.

Solution: Four new cross pipes and two new through-the-bank pipes were installed. Four new turn outs were installed. The road base was built up 18”.
