## Polk Township – Bond Road Project

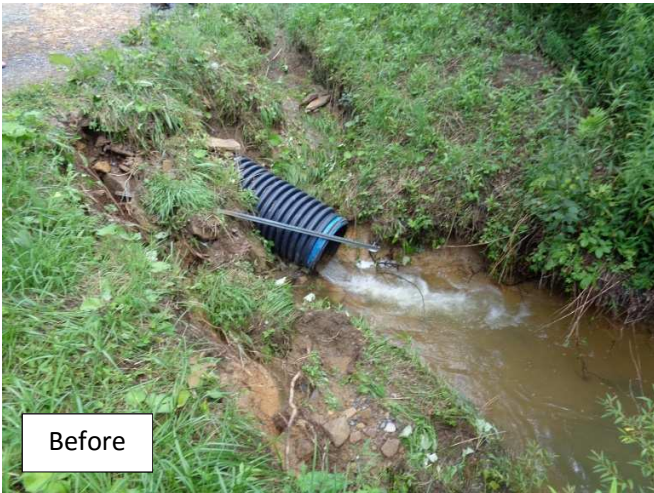
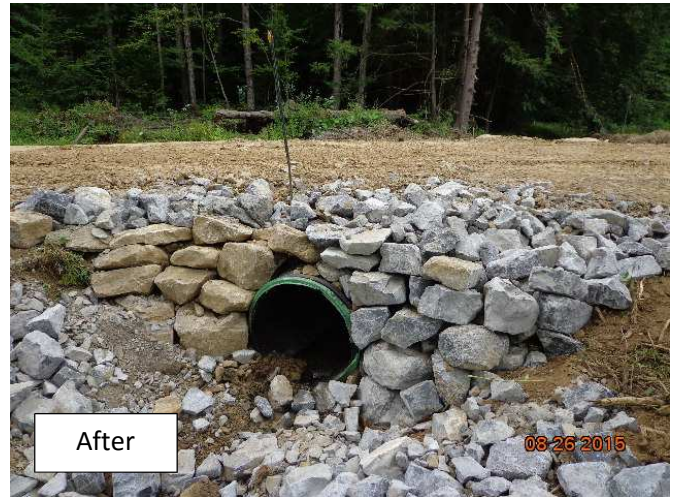
**Problem:** Stormwater from an adjacent Penn DOT Road was being directed onto the Township Road, causing severe erosion. The Township Road was acting like a ditch, conveying sediment laden runoff directly to the stream. Existing springs along the Township Road also contribute to make a soft road base. The existing stream crossing was undersized.
