## Polk Township – Bond Road

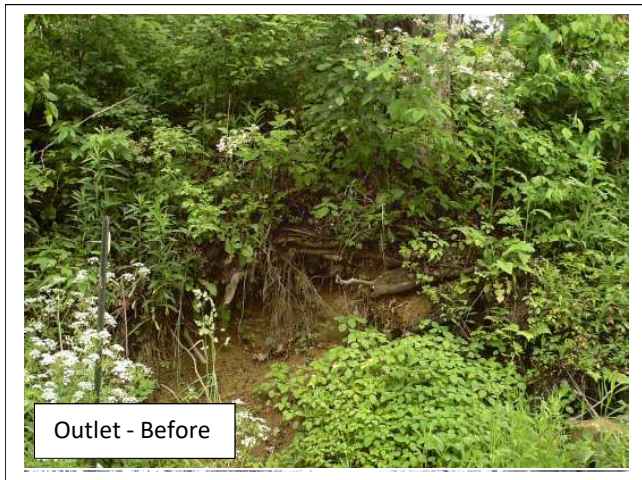
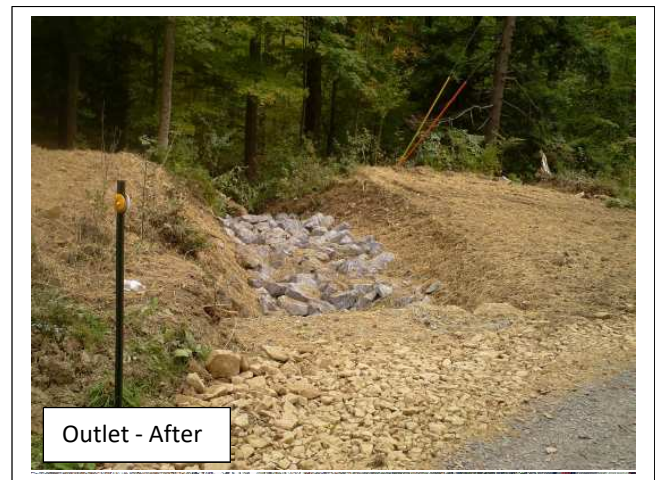
**Problem:** Runoff had to travel a long distance in the road ditch before entering existing cross pipes. The existing cross pipes were undersized and could not handle the runoff from heavy rain events. Runoff overflowed at the cross pipes, causing erosion on the road and at the cross pipe outlets. An outlet from an existing field drain was directed into the road ditch, causing erosion and increased runoff in the ditch.

**Solution:** Larger cross pipes as well as additional cross pipes were installed. Inlet boxes were laid on their sides to stabilize the inlets of the new cross pipes. The field drain was connected into an inlet box. The road base was built up where needed and a grade break was installed. Large stone was installed at the outlets of the cross pipes. Road ditches were lined with large stone to encourage the runoff to slow down.
