Henderson Township – Branch Road

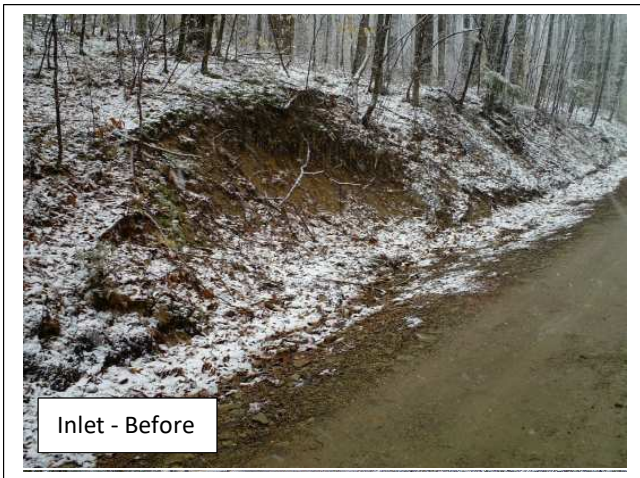
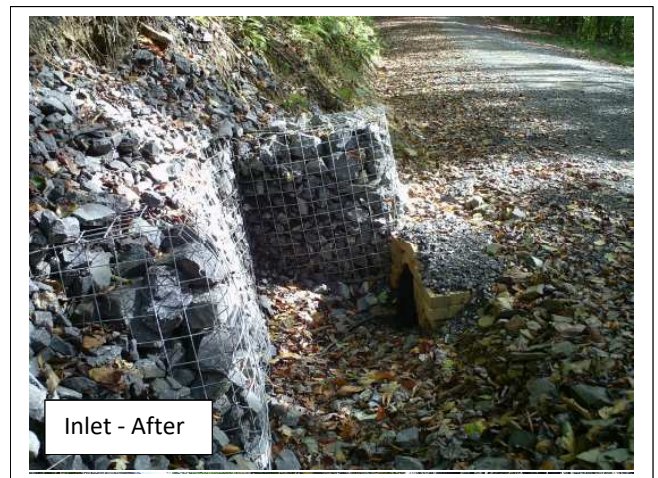
Problem: The road bank was eroding into the inlets of the existing cross pipes. There were not enough cross pipes. The existing road profile was lower than the surrounding area and did not contain a crown. The road was acting as a ditch. The existing ditches were too deep.

Solution: Gabion baskets were installed to support the banks at the inlets. More cross pipes and through-the-bank pipes were added. Headwalls and endwalls were installed on all pipes. Turn outs were installed where possible. Stone aprons were added to filter and disperse any runoff before it would get to the stream. The road base was built up and crowned to promote sheet flow.
