Beaver Township – Boddorf Road

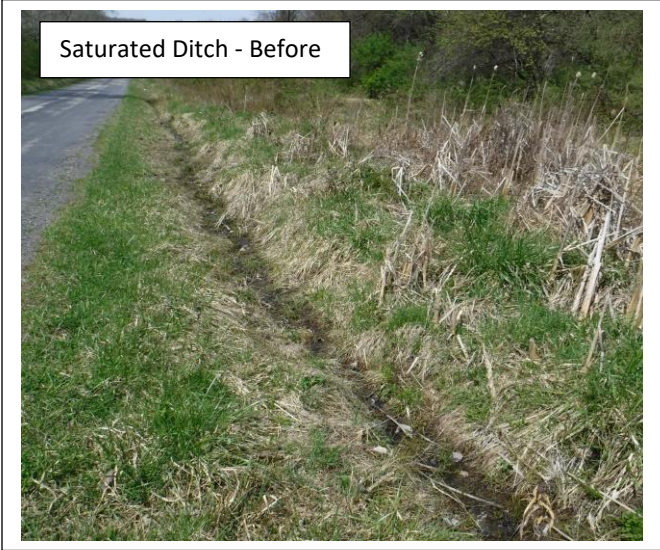
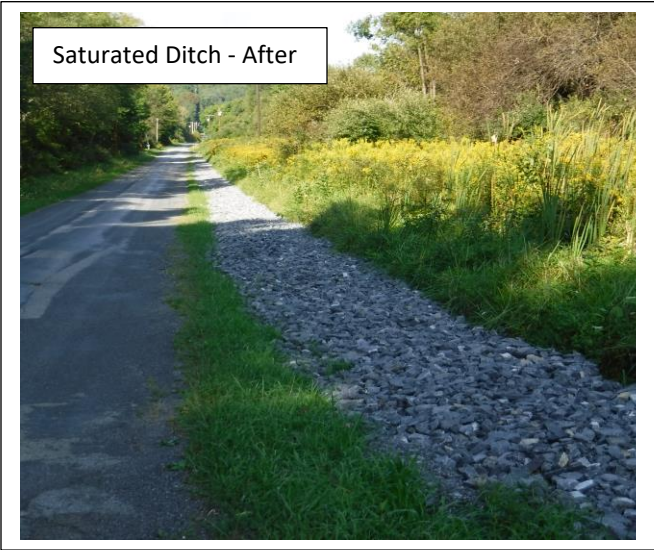
Problem: Existing ditches were saturated with groundwater, causing road base cracking.

Solution: Installation of 540' of 10" underdrain and 300' of 6" underdrain to safely convey groundwater to outlet to a cross pipe. The road was patched where the surface was cracking.
