Oliver Township – Lightning Run Hollow Road

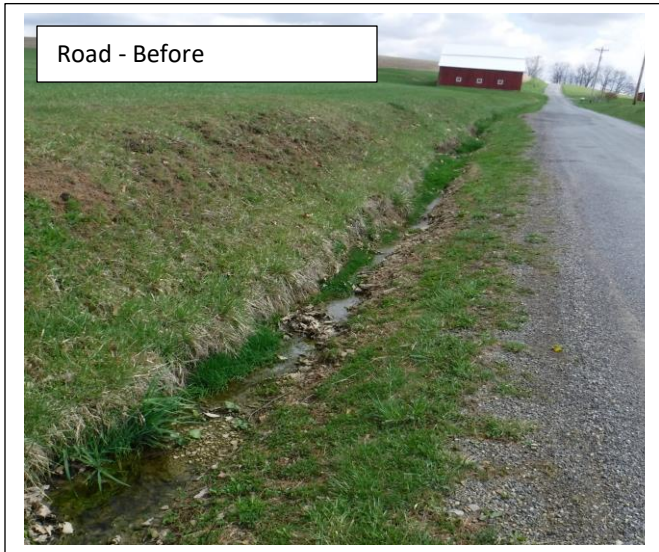
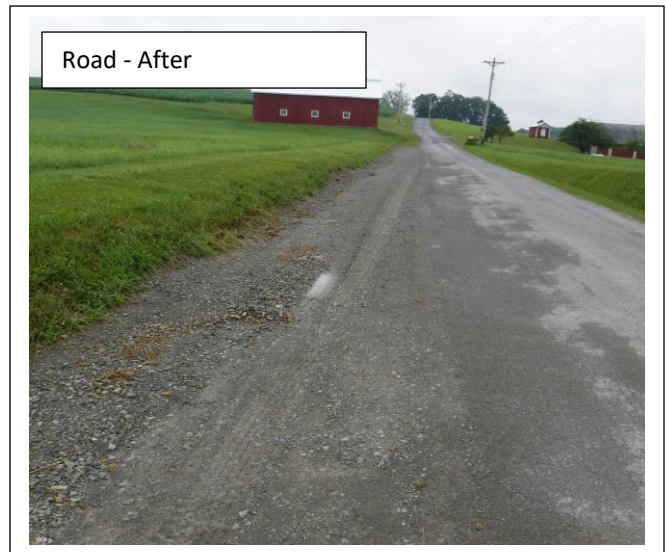
Problem: An existing 12” cross pipe was inadequate to convey runoff from the road ditch and an adjacent pond overflow.

Groundwater was causing the road ditch and road base to become saturated, which also caused the narrowing of the cart way.

Solution: The existing 12” pipe was replaced with an 18” pipe with head and end walls.

Installation of 1200’ of underdrain, stabilizing the previously saturated ditch and reestablishing the appropriate cart way.

Unstable road banks were supported with #1 limestone.

A head wall was established to help stabilize the road bank at the pond overflow.
