Polk Twp – Log Cabin Road

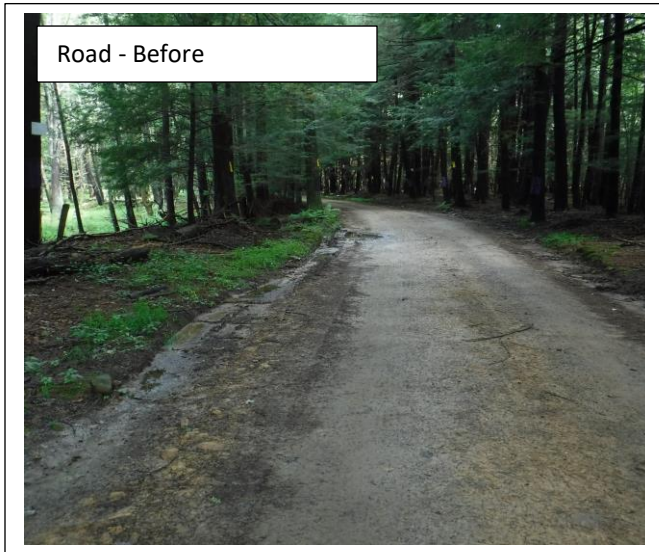
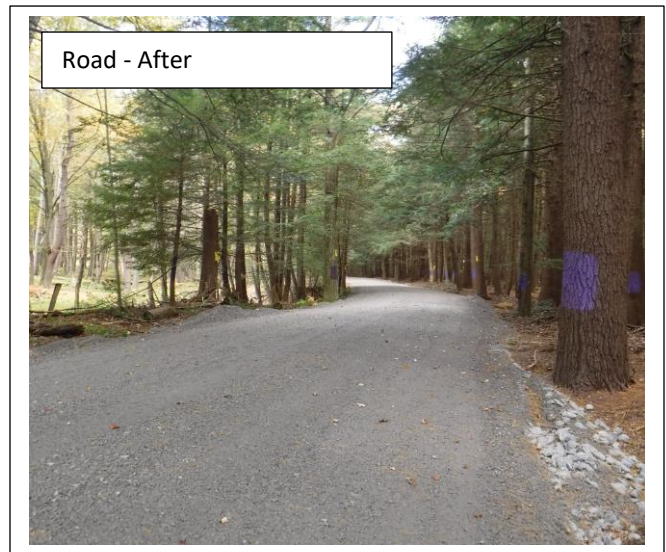
Problem: An inadequate cross pipe and a poor road profile caused surface flow onto the roadway during rain events.

Solution: The existing 12” cross pipe was replaced with an 18” pipe with head and end walls. The road base was built up 16” to encourage sheet flow.
