Beaver Township – Ames Road Low Volume Road (LVR) Project

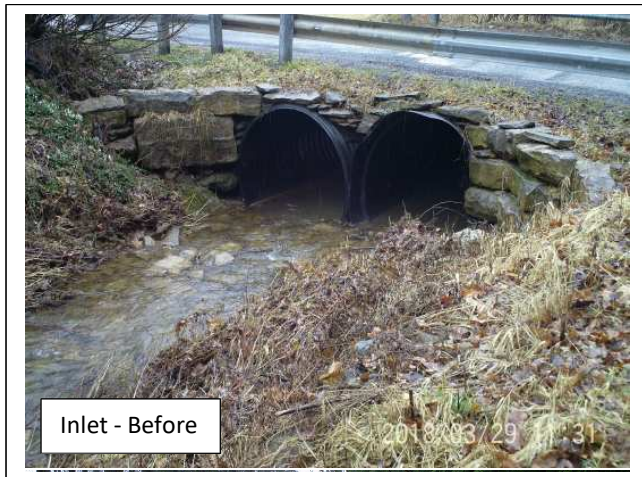
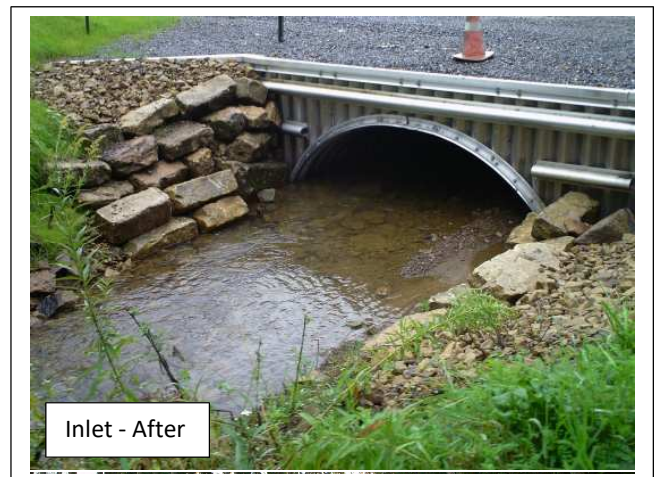
Problem: Water from a roadside spring was carrying sediment directly to the stream. The existing twin plastic pipes that had been joined to a cement box culvert were separating, causing the road to begin to collapse. The twin pipes were causing erosion along the stream banks from the water backup.

Solution: A cross pipe to collect the water from the spring was installed. This diverted the water into a stone filter, dispersing it into a well-vegetated field for filtration. A 12-foot plated arch, aluminum culvert was installed, meeting bankfull requirements. This allows better stream flow with less water backup, stops bank erosion and improves aquatic life passage.
