Kingsley Township – Branch Road Forest County

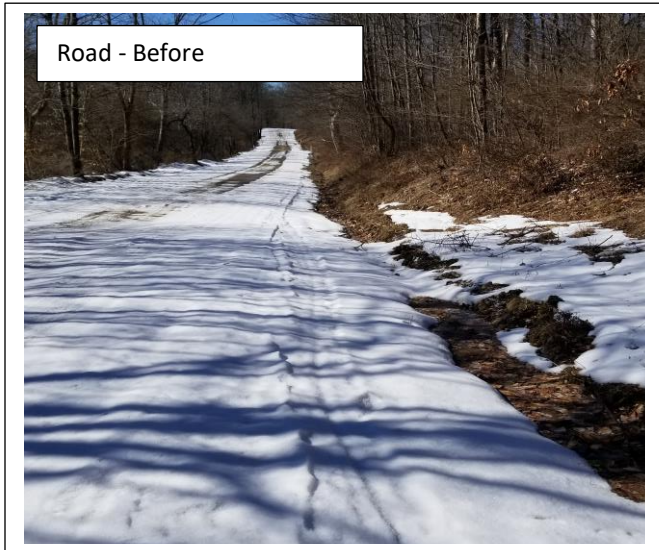
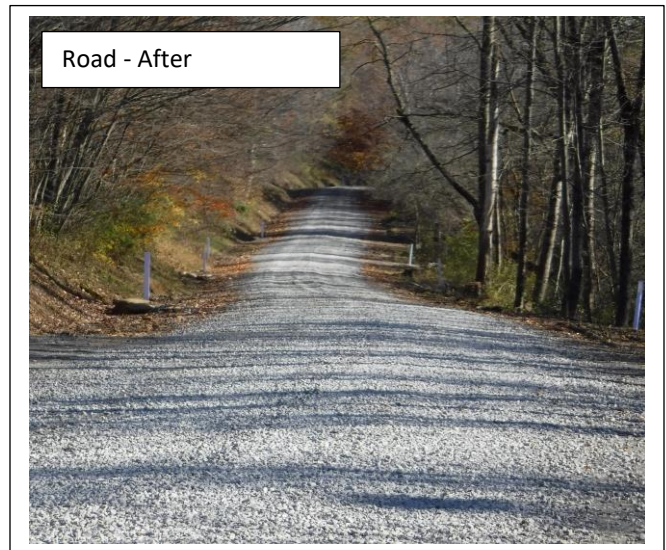
Problem: Existing cross pipes were undersized, and there were not enough. Severe erosion was occurring at the outlets of the existing cross pipes. The poor drainage was causing the road base to become unstable.
