# Oliver Township – Cemetery Hill Road

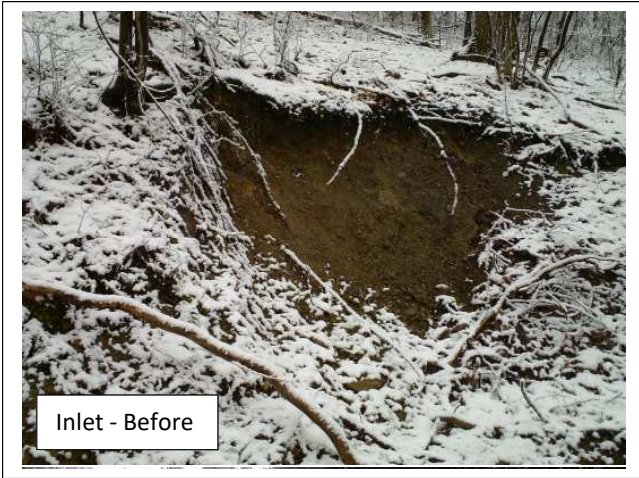
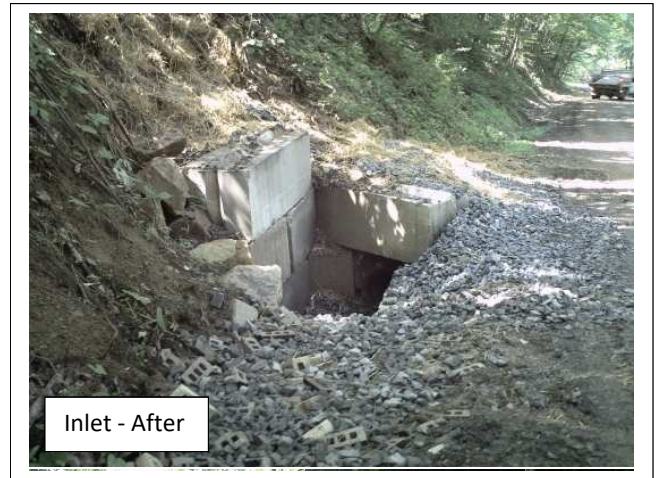
**Problem:** Road banks were eroding into the existing cross pipe inlets. There were roadside springs. There was erosion at the outlets of cross pipes and steep banks. Water was running from springs, coming out of the nearby hillside, flowing along the Township road. This caused the flow in the existing ditch to begin undercutting the road.
