Oliver Township – Hoch Road

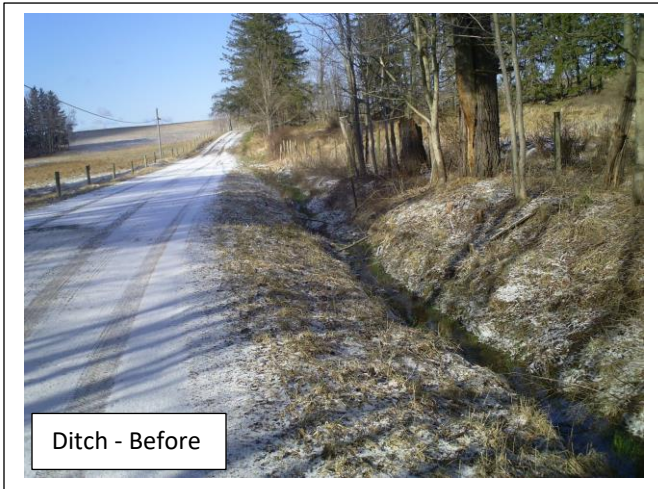
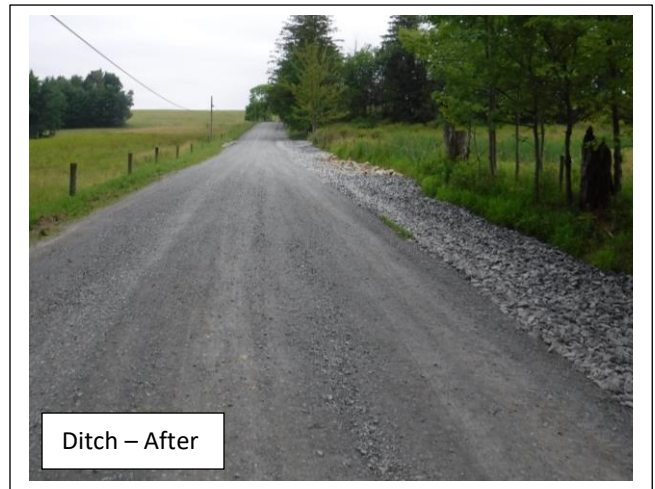
Problem: A wetland and springs along the Township road were saturating the road ditch and road base. There were not enough cross pipes to allow proper drainage. The road was entrenched. The outlet of the existing cross pipe was perched, which caused erosion.

Solution: – The Township installed 760' of 6" underdrain and 700' of 10" underdrain. A 12" cross pipe was replaced with an 18". An additional 18" cross pipe was installed. 1,045 tons of road fill were added to raise the road profile and encourage sheet flow. R5 stone was installed at the pipe outlet to prevent erosion. Areas were seeded and mulched as needed.
