# Polk Township – Dixon Road

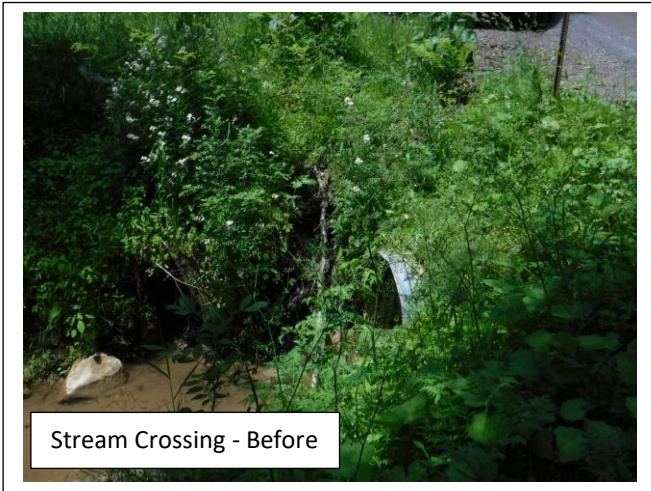
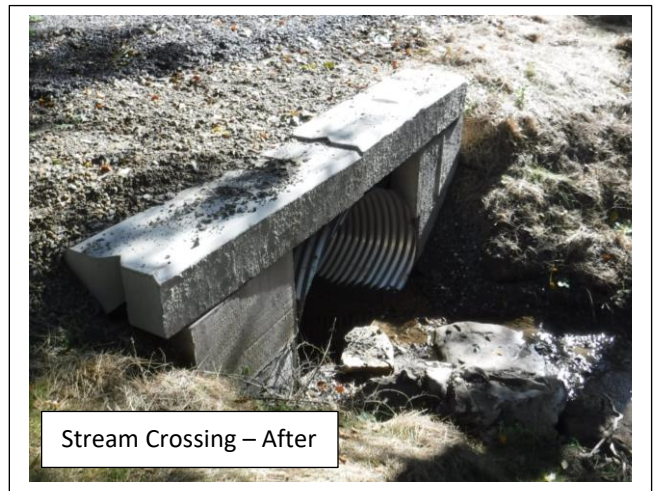
**Problem:** The existing stream crossing was too small, which caused erosion on the streambanks and stream bed. Water was running in the road ditch for a long stretch, causing deep ditches. The road was entrenched.
