Tionesta Borough – Elm Street Forest County

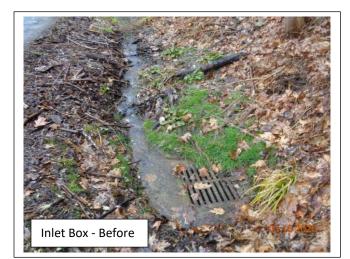
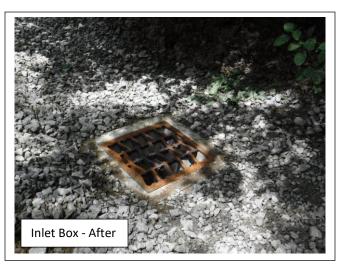
Problem: The existing cross pipes were too small. The existing end walls were crumbling and falling into the outlets. Erosion was occurring at the outlets of the existing cross pipes. Some of the inlets needed stabilized.

Solution: Four existing 10-inch diameter cross pipes were replaced with 18-inch diameter cross pipes. The crumbling end walls were rebuilt. An inlet box was installed. The inlets were stabilized with #1 stone to help filter out any sediment. R4 stone was installed at the outlets to help slow water down and prevent erosion.
