# Worthville Borough – Cliff Street

## Low Volume Road Project

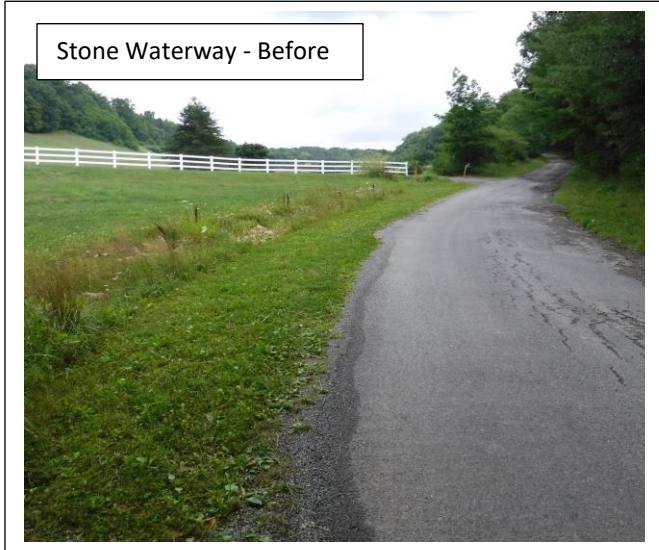
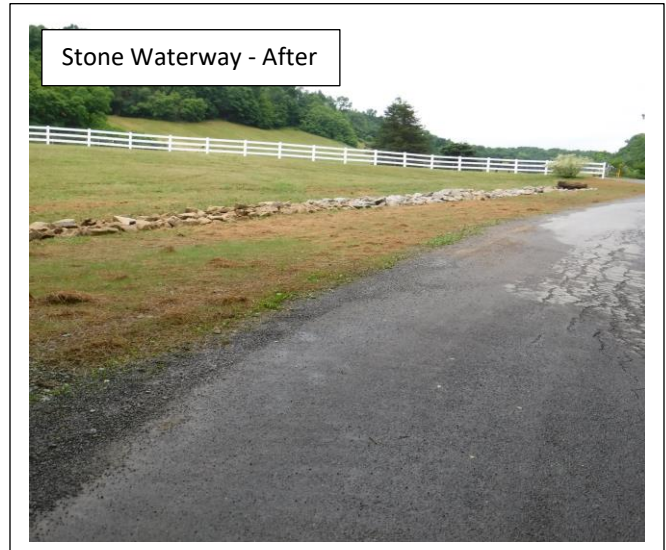
**Problem:** An existing stone lined ditch could not carry heavy rain events and flooded the Borough Road. Existing pipes along the Borough Road transitioned from a 24” pipe down to a 15” pipe, causing repeated flooding. Repeated flooding caused severe erosion around the outlet of an undersized cross pipe.

**Solution:** The existing 15” and 24”undersized pipes were replaced with a 3’ squash pipe. The existing ditch was removed and stabilized; 137’ of stone lined waterway was established to safely convey runoff to a well vegetated area. The 12” existing cross pipe was replaced with an 18” cross pipe with head and end walls, with R5 stone stabilizing the outlet.
