Young Township – Cunningham Road Project

This is a Low Volume Road (LVR) Project.

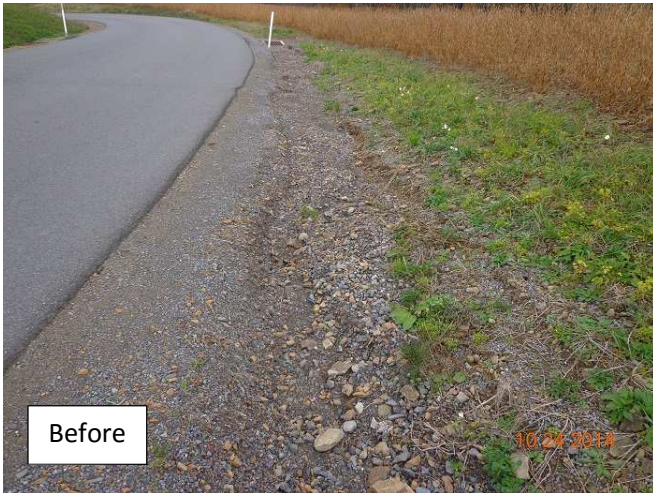
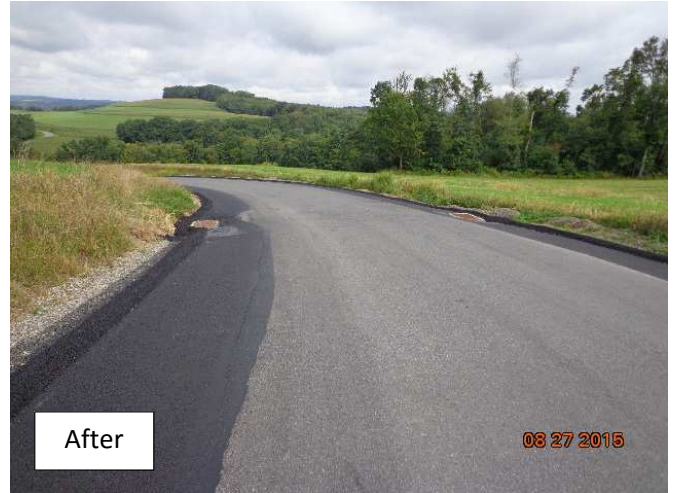
Problem: Stormwater from the top of the hill was running down the unstable berms of the paved road, causing the berms to erode. Sediment washed into inlets and plugged the existing pipes. The tail wall of an existing stream crossing was not adequate.

Solution: Berms were widened to 4 feet and paved with a curb. Sediment was removed from the inlets and the plugged pipes. A new tail wall was constructed.
