Henderson Township – Kramer Road Project

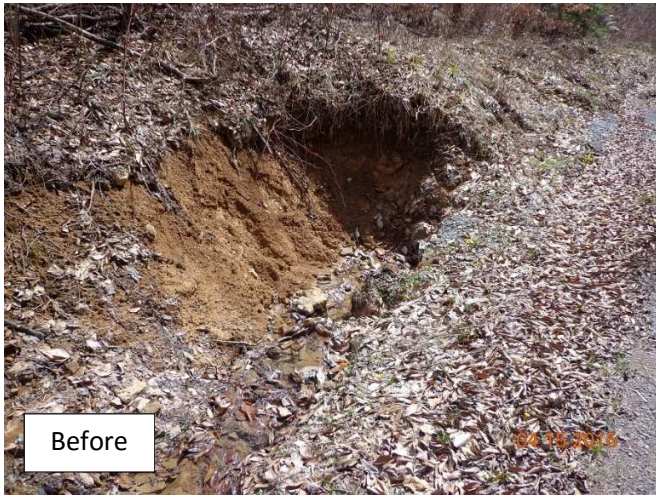
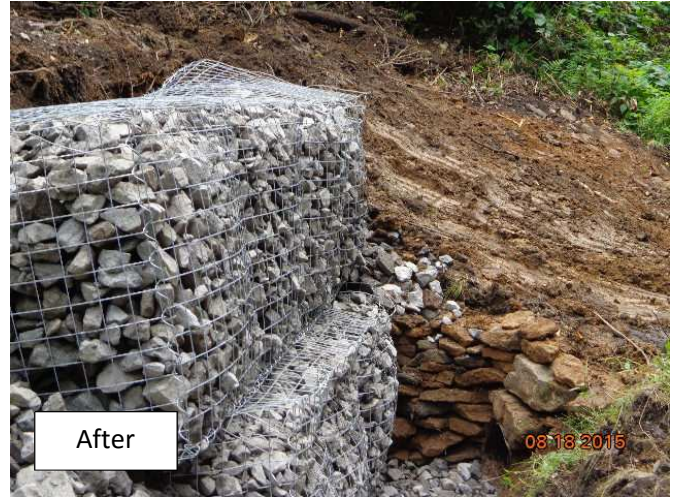
Problem: Existing turnouts were clogged with sediment and would not let runoff away from the roadway. Ditches were washing out and carrying sediment to the stream. Banks surrounding the existing inlets were eroding into the inlets and plugging the pipes.

Solution: All clogged turnouts were cleaned out and stabilized with vegetation. Filter stone was placed in eroded ditches to stabilize them. A new cross pipe was installed to improve drainage. New head and tail walls were installed on an existing pipe to provide stabilization. Gabion baskets were built to hold back the steep, eroding banks around the pipe inlets. Driving Surface Aggregate (DSA) was placed to stabilize the cart way.
