McCalmont Township – Hemlock Road Project

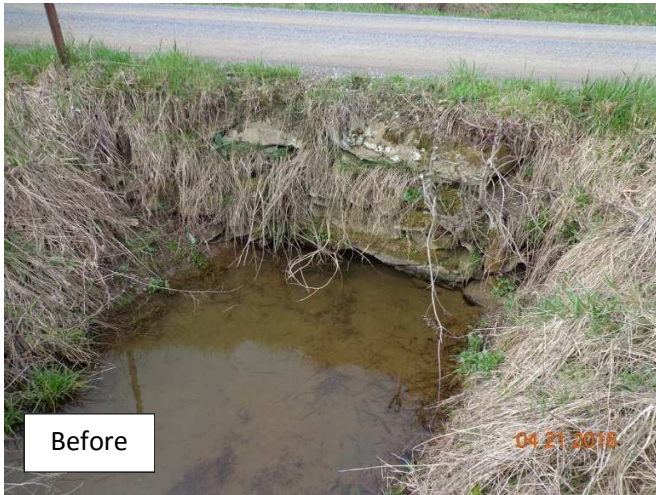
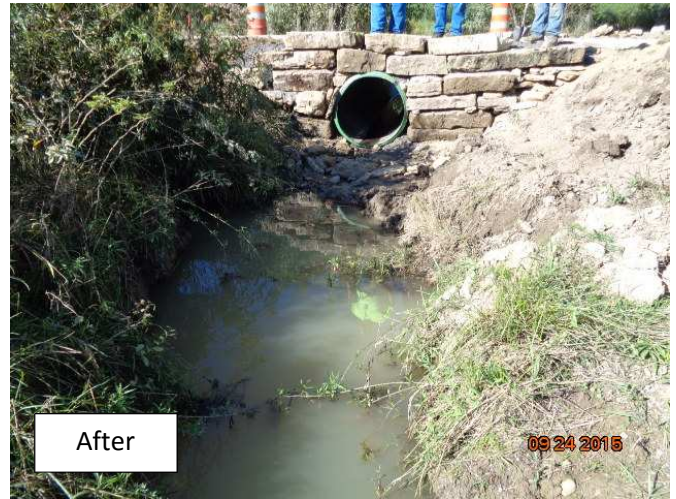
Problem: Stormwater runoff was entering the entrenched roadway from an adjoining driveway as well as the top of the hill. Since runoff cannot leave the roadway, erosion is occurring and sediment is going into the nearby stream. The existing stream crossing is collapsing and is not functioning properly. The road profile was very flat.

Solution: A new stream crossing was installed with stable head and tail walls. The road base and the connecting driveway were built up and shaped with an average of 1 foot of shale to encourage the water to sheet off the road into vegetated areas. New turn outs were installed.
