Warsaw Township – Crawford Road

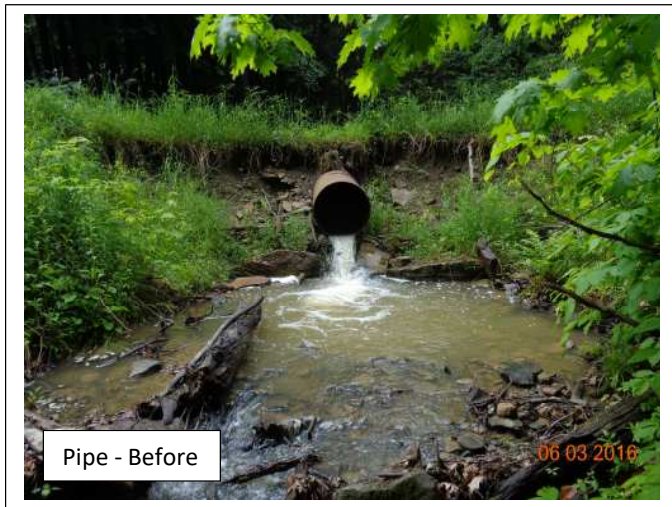
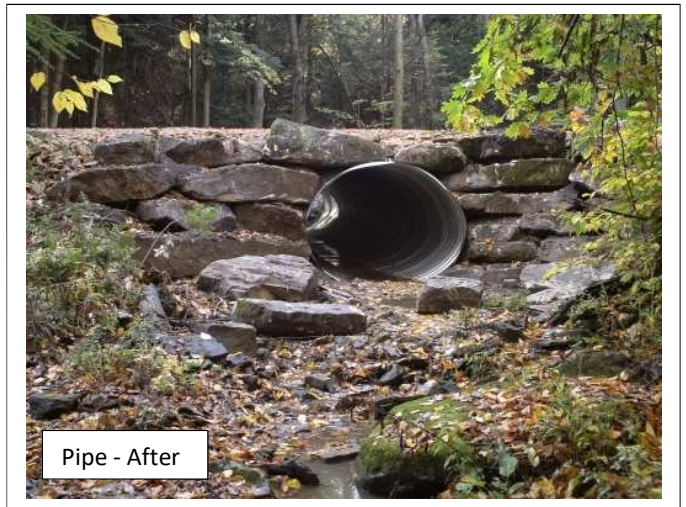
Problem: The existing stream crossing was undersized and the road was acting as a ditch. Wet areas along the road were causing the ditches and road base to become saturated and form a large number of potholes.

Solution: A larger stream crossing was installed. A new underdrain and additional cross pipes were installed. The road was built up and turnouts were installed. The banks were graded to allow sheet flow and were stabilized with rip rap.
