Beaver Township – Ames Road

Low Volume Road Project

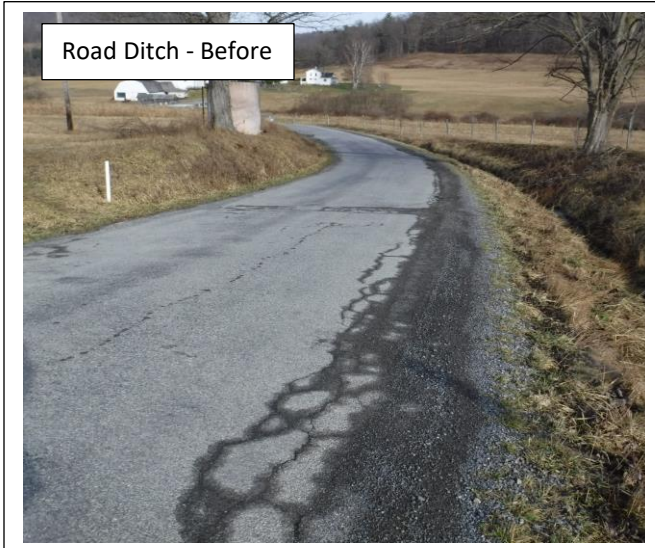
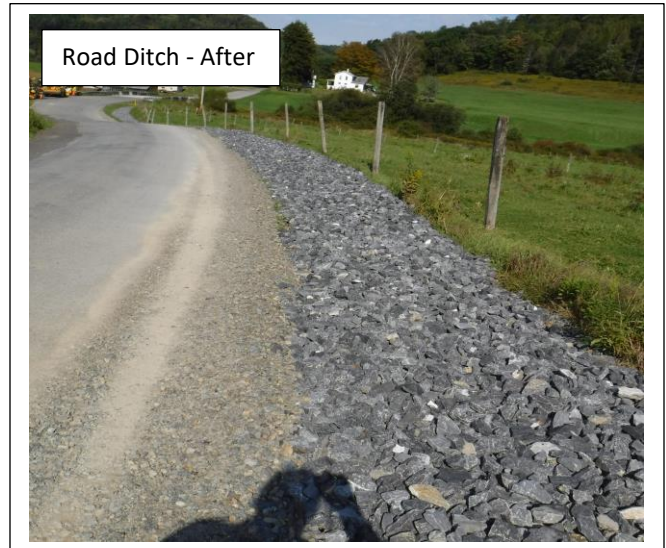
Problem: Runoff from an existing Penn Dot cross pipe and a spring located in the middle of the Township Road were saturating the Township Road ditch with flowing water. Sediment was being conveyed directly to the stream.

Solution: Installation of an inlet box to capture the water from Penn Dot's cross pipe, 5 additional inlet boxes in the Township Road ditch and 750' of 18" underdrain in the ditch between the new inlet boxes.
