Heath Township – Spring Creek Road

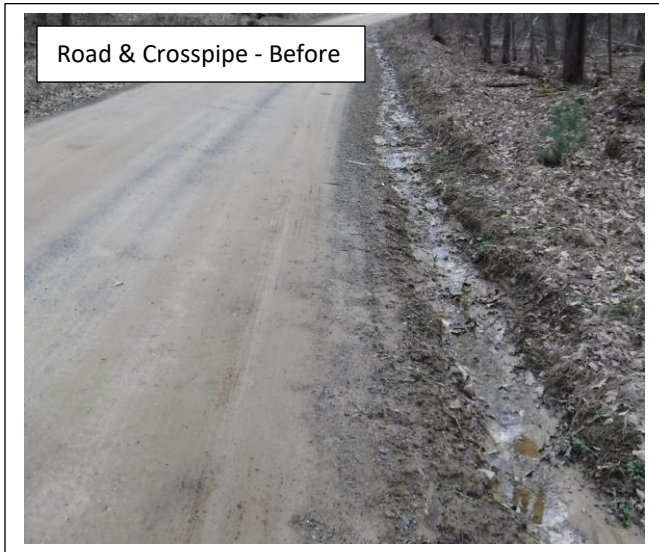
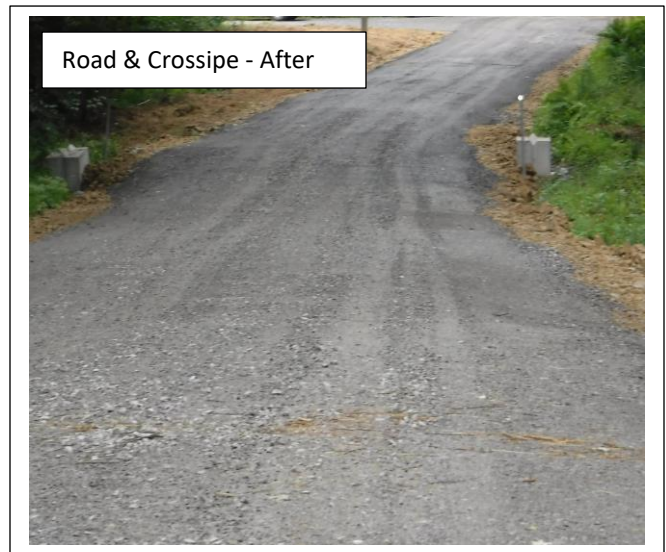
Problem: Two roadside springs were overwhelming an existing cross pipe. One roadside spring was saturating the existing ditch, road base and flowing across the Township Road. This caused the road and the road base to become soft. Sediment was being conveyed in the road ditches during rain events.
