## Knox Township - Sentner Road

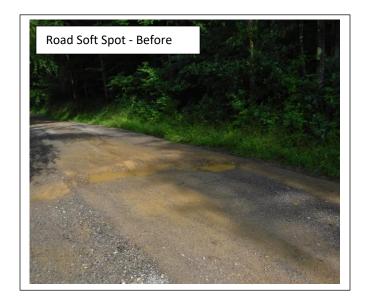
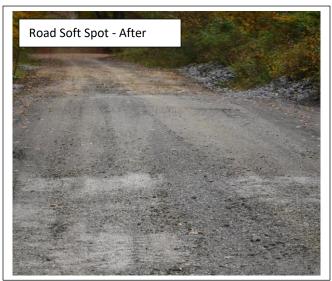
**Problem:** Large amount of runoff being conveyed down a steep grade in an excessively deep ditch. A spring located in the roadway. The entrenched road provided no option to outlet the runoff, causing the road ditch and road base to become saturated. An existing cross pipe was inadequate during rain events.

**Solution:** The road base was built up on the steep grade, while also filling in the deep ditch. Four turnouts were installed to provide outlets for runoff to exit the roadway. Stone filters were installed at their outlets. Installation of a 152 sq ft French mattress to capture the spring in middle of road. Installation 600' of 6" underdrain. The inadequate cross pipe was replaced with an 18" pipe with head and end walls. Disturbed areas were seeded and mulched.
