Perry Township – Frostburg Road

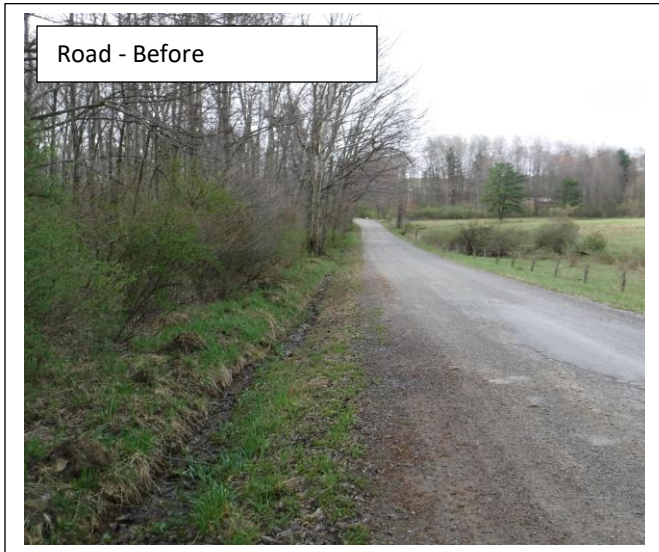
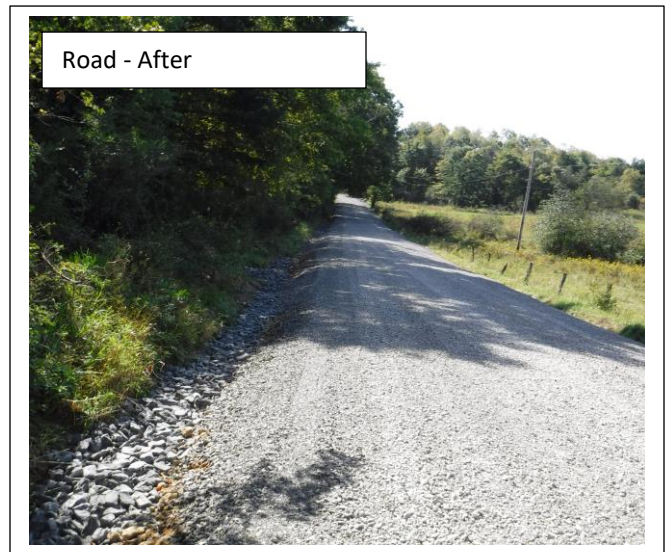
Problem: 3 roadside springs were saturated road ditches, with constant flow causing them to cut deeper, conveying sediment directly to the nearby stream. This saturation was also causing the road base to become unstable.

Solution: Installation of 393' of 10" underdrain and 312' of 6" underdrain to safely capture spring flow.

Stone filters were installed at the outlets of the underdrains prior to reaching the nearby stream.

The road base was built up 1' and 2 turnouts were installed to encourage any runoff away from the roadway.
