Ringgold Township – Sherry Hollow Road

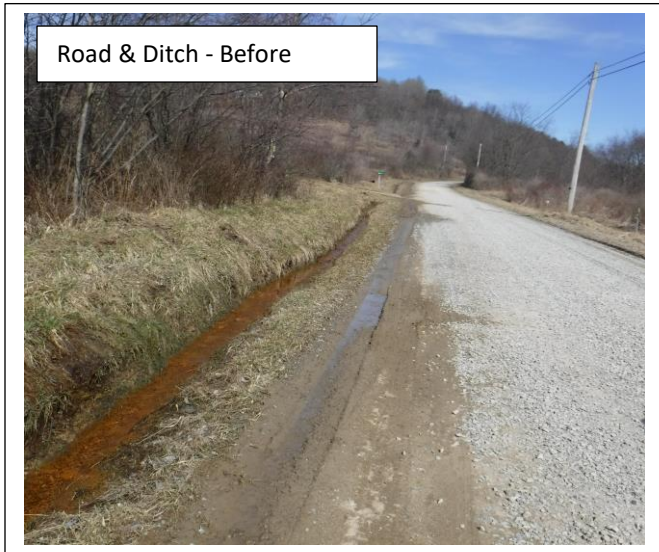
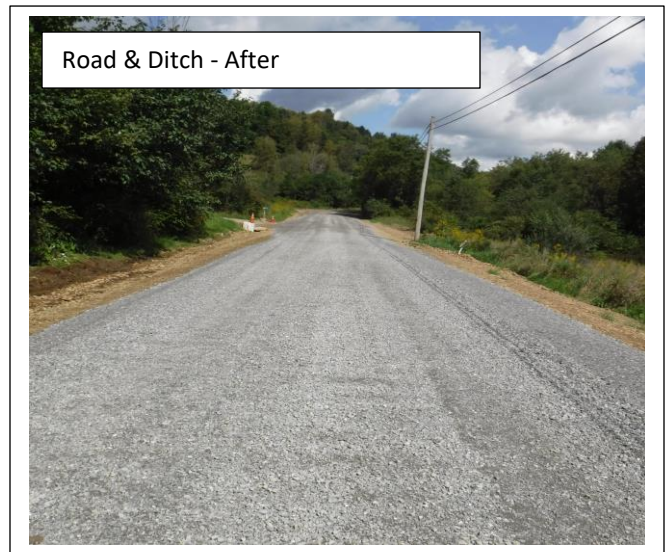
Problem: Excessive runoff in a long length of road ditch that also discharged directly to a stream. The saturated ditch along with springs along the road caused the base to become soft.

Solution: The inadequate 15” cross pipe was replaced with an 18” pipe.

Installation of 880’ of underdrain.

Installation of a new cross pipe and two new turnouts to discharge runoff into well vegetated areas.

Head and end walls were installed on each cross pipe.

The road was built up 1’ to encourage sheet flow.

Disturbed areas were seeded and mulched.
