## Bell Township – Summit Road

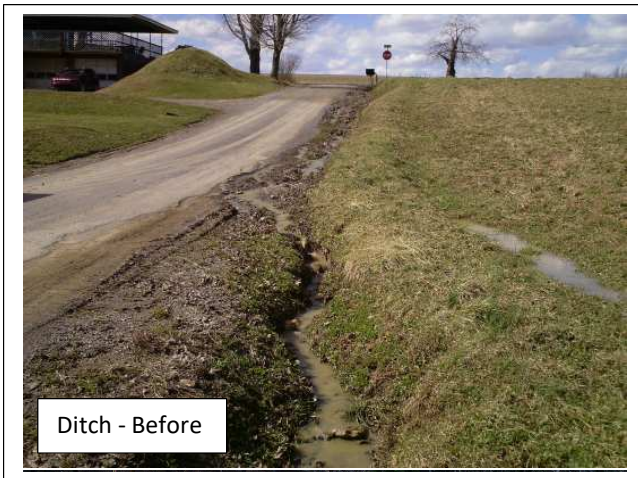
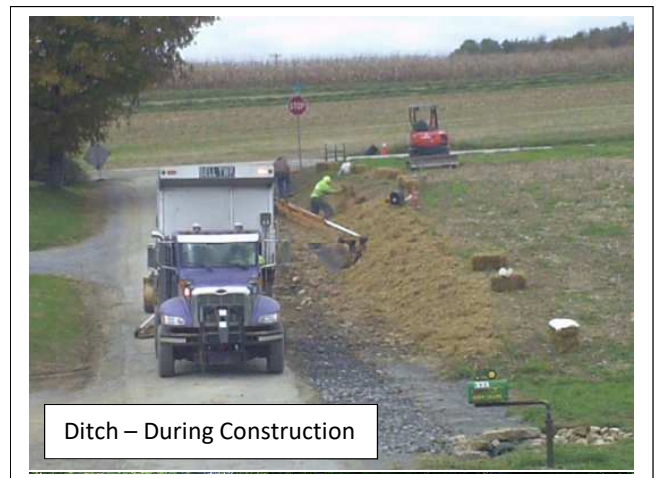
**Problem:** Underground springs were leaching out of the road bank and flowing into the existing road ditch. A field drain also discharged into the existing road ditch. The road profile was low and causing the road to act as a ditch, carrying sediment directly to the stream. Severe erosion occurred in the ditch due to several large rain events.

**Solution:** – 1,100 feet of underdrain was installed to collect water from the springs and field drain. A pipe to convey water from the ditch was installed to stop erosion. A stone filtering system was built and an endwall was installed at the outlet of the pipe. The road profile was built up 2' to 3' and crowned to encourage sheet flow. The road bank was also sloped to prevent the ditch erosion.
