Eldred Township – Turner Road

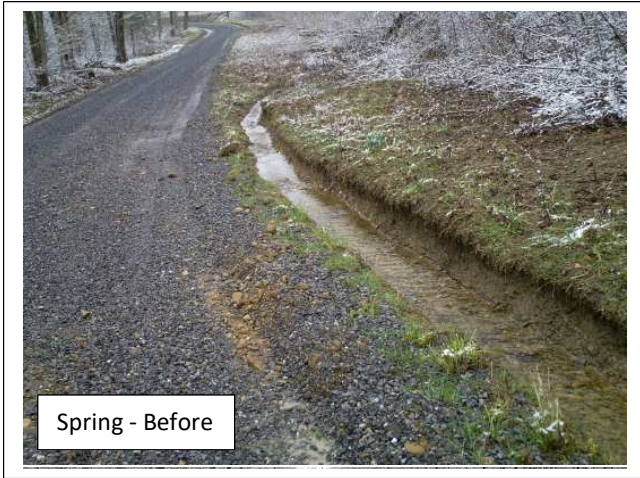
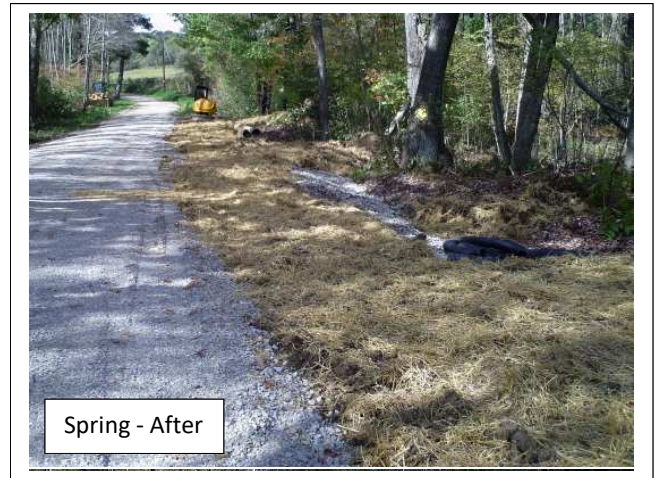
Problem: An underground spring was discharging directly into the road base, causing it to become saturated. An existing cross pipe had collapsed. The road profile was not crowned.

Solution: A pipe to collect the spring water was installed on the upgradient side of the road. The collected water was then dispersed into a grassy area to dissipate and filter before reaching the stream. A French mattress was installed to let water pass through the road base and provide support. The cross pipe was replaced with a larger pipe. The road profile was built up and crowned to encourage sheet flow.
