Jenks Township – Greeley Farm Road Forest County – Low Volume Road Project

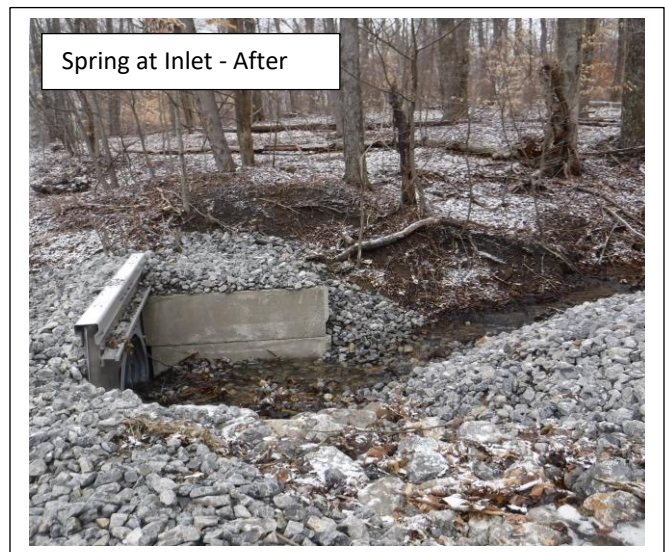
Problem: A continuous flow of water from numerous roadside springs and an extended length of paved road ditch. The existing cross pipe was severely undersized and a portion of it was filled with debris. The bottom of the existing cross pipe had completely eroded away. The outlet of the existing pipe was perched and was causing severe erosion.

Solution: A 6' squash pipe was installed, as well as head and end walls. A stable stream bed gradient was reestablished stabilize the area and prevent future erosion. The Surrounding streambanks were stabilized with stone to provide additional support. A stone lined ditch was placed at the end of the paved road ditch to stabilize the area before the pipe inlet.
