McCalmont Township – Native Road

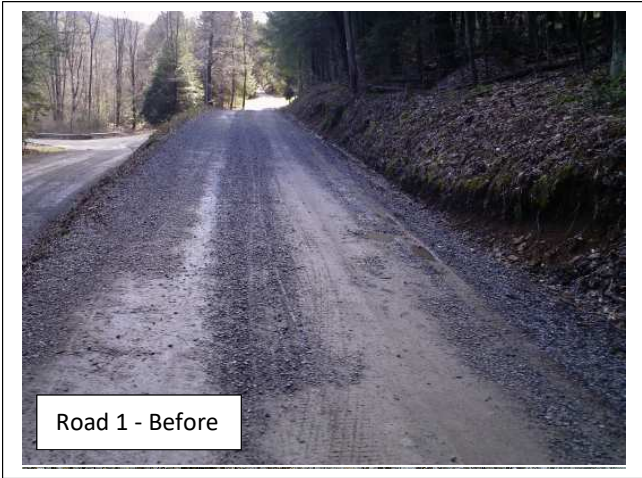
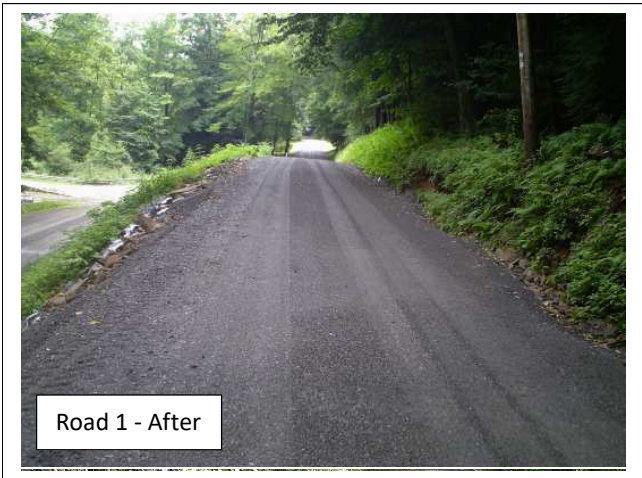
Problem: The roadside springs were saturating the existing ditches and road base. Sediment was running into the nearby stream from the road surface. The road bank was eroding into the inlet of the existing cross pipe.

Solution: Underdrains and larger cross pipes were installed. Geotextile fabric was installed for road base support. The road base was built up to improve the road profile and encourage sheet flow. Gabion baskets were installed at the pipe inlets to support the banks.
