Oliver Township – London Road

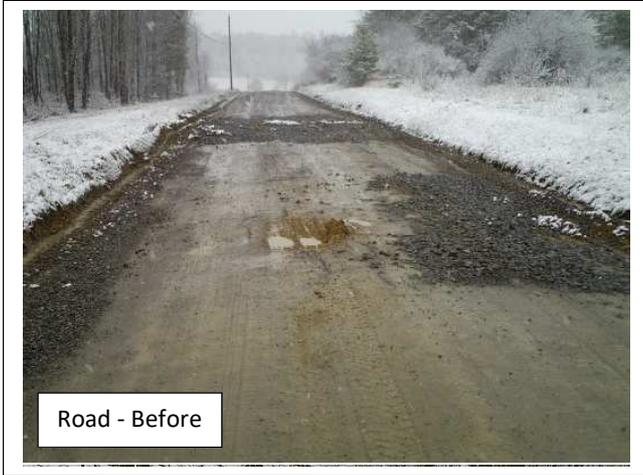
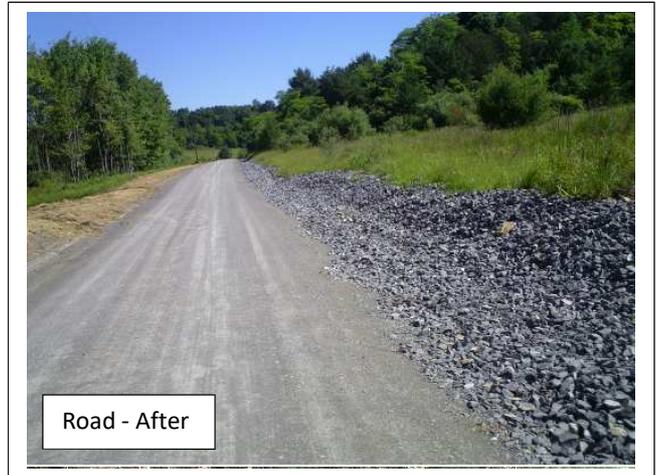
Problem: There was a wetland along the Township road, saturating the base and causing water to spring up in the middle of the road. This made the road base soft and created a large amount of sediment in the roadway. There was flowing water in the ditches, carrying sediment directly to the stream.

Solution: – An underdrain was installed to help keep the groundwater sediment free and to keep it from impacting the road base. A French mattress was installed. The road base was built up by placing geotextile fabric under shale to improve the road profile.
