PA Game Commission – Rainetown Road

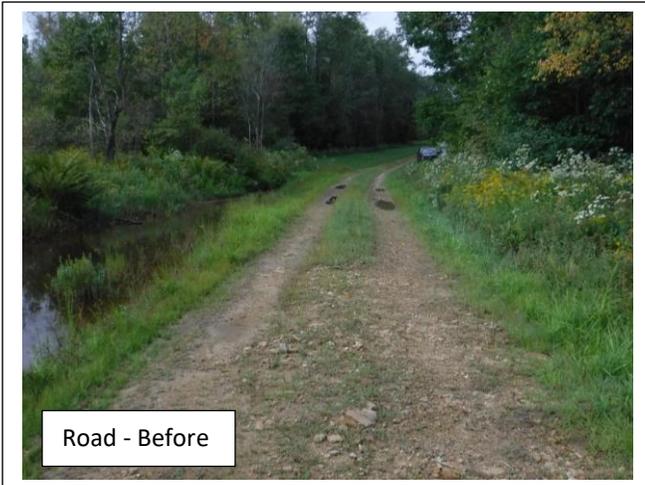
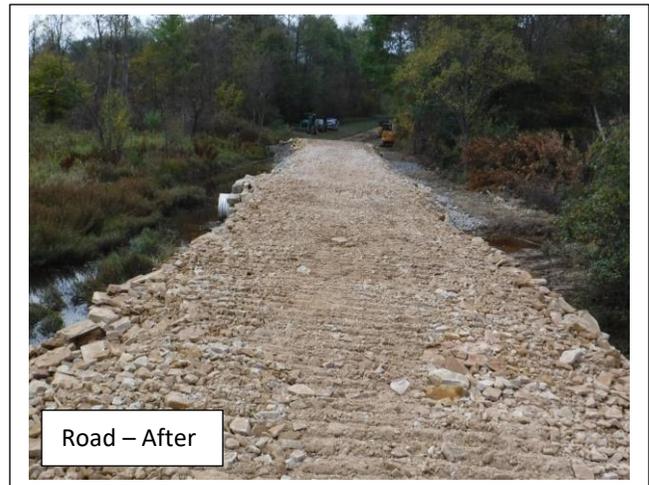
Problem: Wetlands are on both sides of the road. Water from one side occasionally overtopped the road, which caused erosion and carried sediment into the wetland on the opposite side. The elevation of an existing overflow pipe was too high and was in an unfavorable location.

Solution: – A 36” squash pipe was installed as a stream crossing. Two 24” overflow pipes were installed in better locations. Headwalls and endwalls were built as well as a 360’ French Mattress. Two turnouts were installed. 621 tons of road fill were placed to raise the road profile. Disturbed areas were seeded and mulched as needed.
