Porter Township – Nye Branch Road

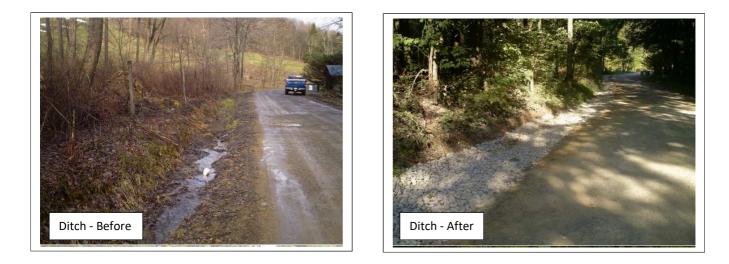
Problem: A roadside spring flowed into the road ditch, causing the it to become saturated and the road base to sink. A small stream discharged into the road ditch and flowed in two different directions, adding additional flow and saturation to the ditches. Existing cross pipes were undersized.

Solution: An underdrain was installed to catch the road side spring and convey it away from the road base. Underdrains were installed to alleviate the saturated ditches. New cross pipes were installed as well as a stream crossing. The road base was built up 12", to encourage sheet flow.
