# Ringgold Township – Caylor Road

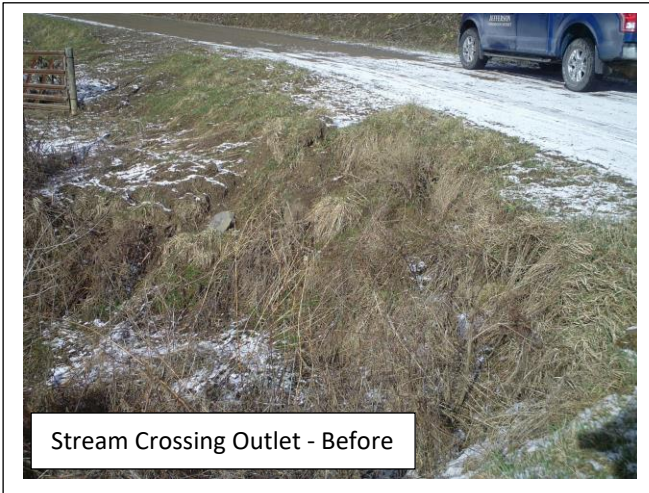
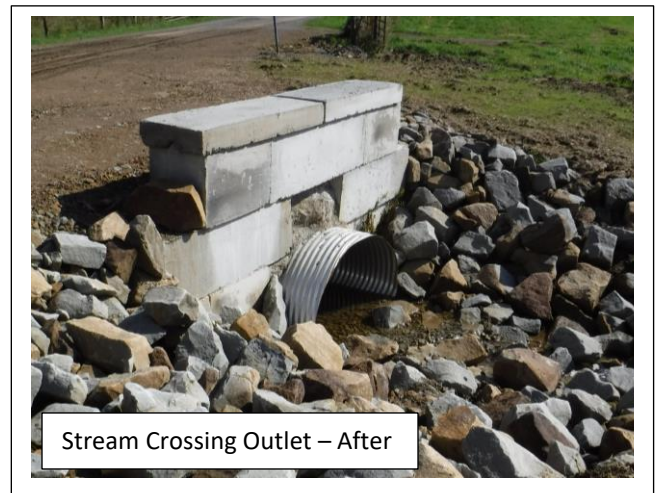
**Problem:** The existing stream crossing had double pipes and they were too small, which caused erosion on the surrounding streambanks. Water was running very long distances in the road ditches, carrying sediment directly to the stream.

**Solution:** – A five-foot stream crossing was installed with headwalls and endwalls. The outlet was lined with R5 stone. A new 18” cross pipe with headwalls and endwalls was installed. 212 tons of road fill were added to encourage sheet flow during rain events. Disturbed areas were seeded and mulched as needed.
