## Tionesta Borough – Cemetery Street Forest County

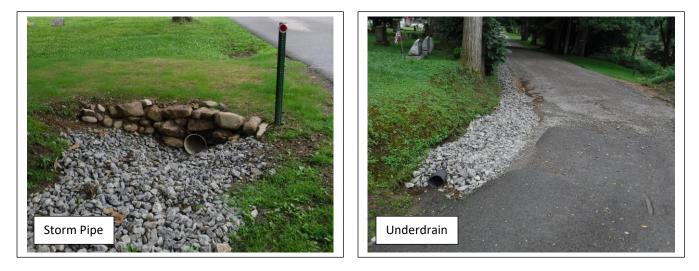
**Problem:** Water from a paved parking area was running onto the Borough road, causing erosion and carrying sediment directly to the river. Water was laying in the existing ditches since there were no outlets. The existing road profile was lower than the surrounding area.

**Solution:** A pipe was installed to catch water from the parking area and outlet it to a stone filter area before going to the river. A crosspipe was installed to collect water from the road ditch and deposit it into an outlet box. The road base was built up with 808 tons of stone to crown the road and encourage sheet flow during rain events. Disturbed areas were seeded and mulched as needed.
