Tionesta Township – Stitzinger Road

Forest County

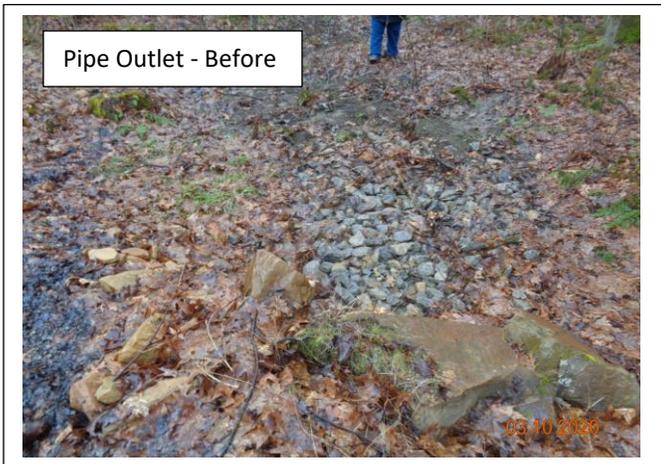
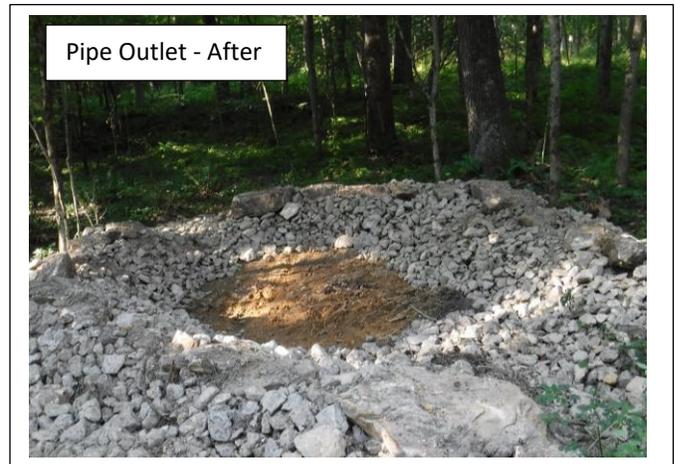
Problem: A large amount of offsite runoff was accumulating in one area of the roadway at a high rate of speed. The road was entrenched. Existing ditches were extremely eroded. Large amounts of sediment were being conveyed directly to the stream.

Solution: A tear drop filtration system was constructed to slow the runoff to encourage any sediment to fall out. This would also help prevent down-gradient erosion. An additional tear drop system was installed at the inlet of a new stone lined channel as an additional measure to encourage the runoff to slow down. The road was built up 3 to 4 feet to establish a crown and to encourage sheet flow during rain events. An existing 15-inch driveway pipe was installed with a 2-foot diameter squash pipe to promote better ditch flow. Disturbed areas were seeded and mulch.
