Tionesta Township – Passauer Road

Forest County

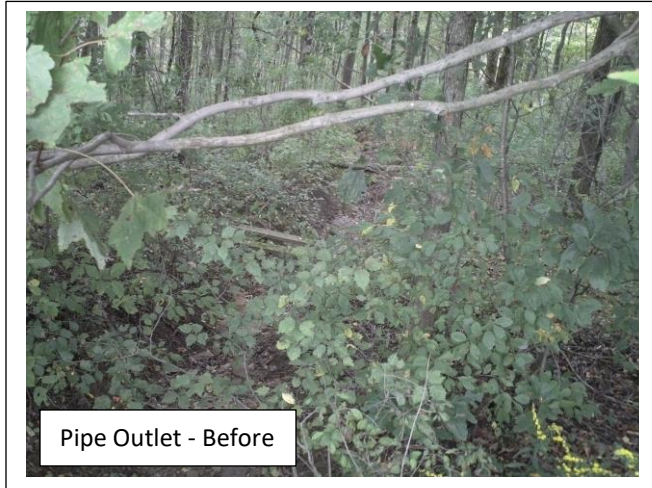
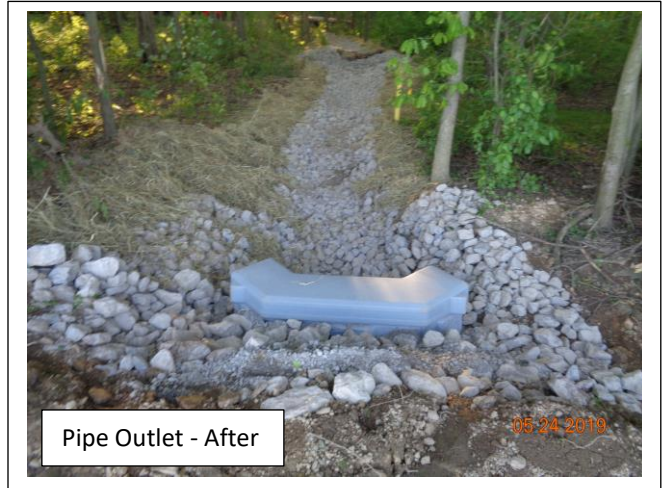
Problem: A large amount of stormwater was concentrating between two Township roads, causing a severely eroded gully to form. Existing crosspipes were too small. The outlets of the existing crosspipes were failing, causing the surrounding banks to erode.
