Tionesta Borough – Elm Street Forest County

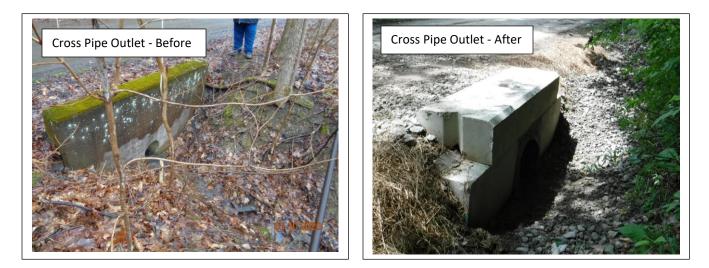
Problem: The existing cross pipes were too small. The existing end walls were crumbling and falling into the outlets. Erosion was occurring at the outlets of the existing cross pipes. Some of the inlets needed stabilized.

Solution: Four existing 10-inch diameter cross pipes were replaced with 18-inch diameter cross pipes. The crumbling end walls were rebuilt. An inlet box was installed. The inlets were stabilized with #1 stone to help filter out any sediment. R4 stone was installed at the outlets to help slow water down and prevent erosion.
