Barnett Township – Songer Road Project

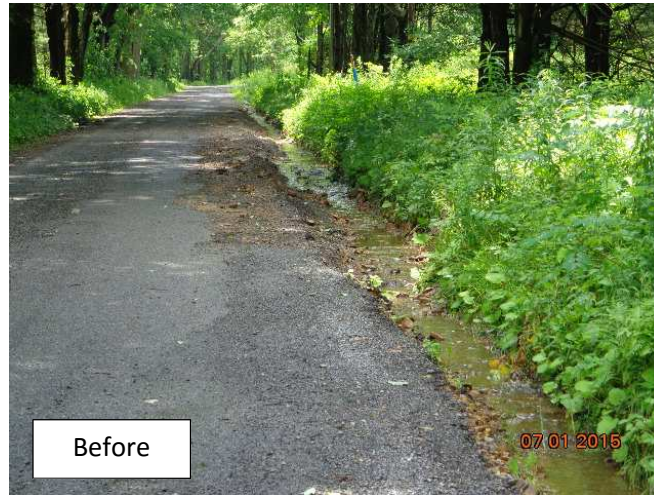
Problem: Water from several sections of Songer Road was being directed onto Shaffer Road, where it was washing out the ditches and eroding the existing driving surface.

Solution: A new cross pipe, headwall and tailwall, were installed across Songer Road to divert water away from Shaffer Road and into a grassy area.
