Barnett Township – Shaffer Road

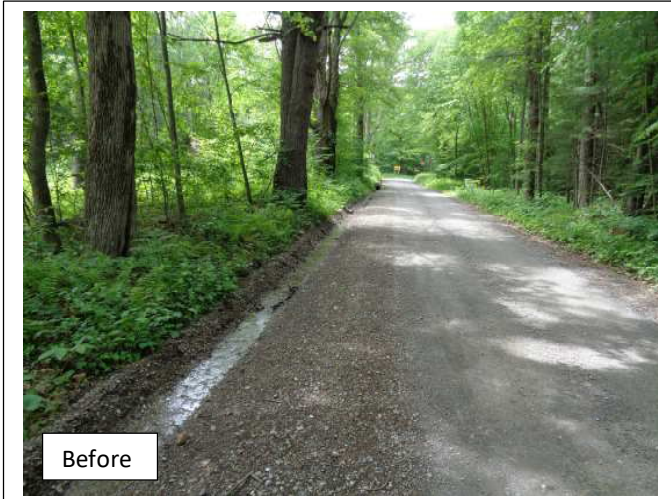
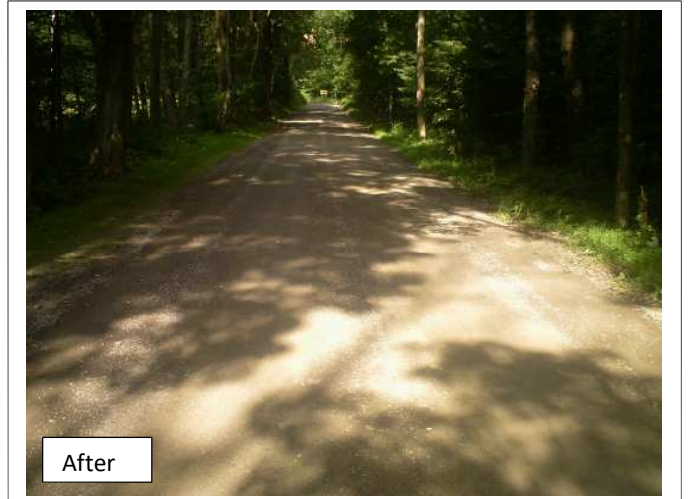
Problem: A large amount of water coming from a roadside spring on a connecting road saturated the ditches. This water also saturated the road base, causing it to break down. Large amounts of sediment were running off the road and ditch, clogging an existing turnout, causing the water to back up and flood the roadway.
