Barnett Township – Songer Road

This is a Low Volume Road (LVR) Project.

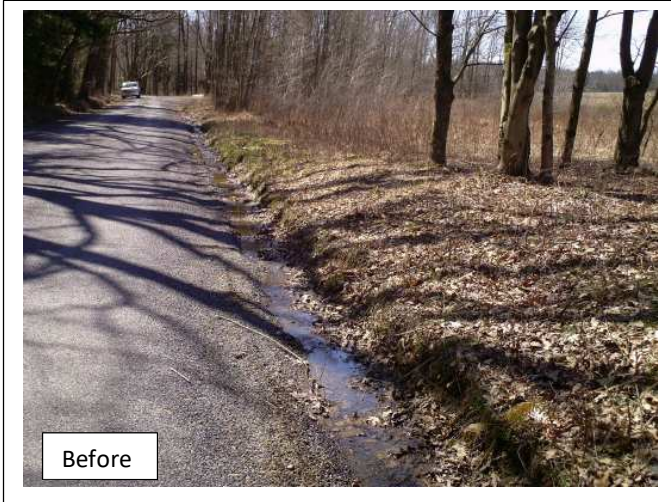
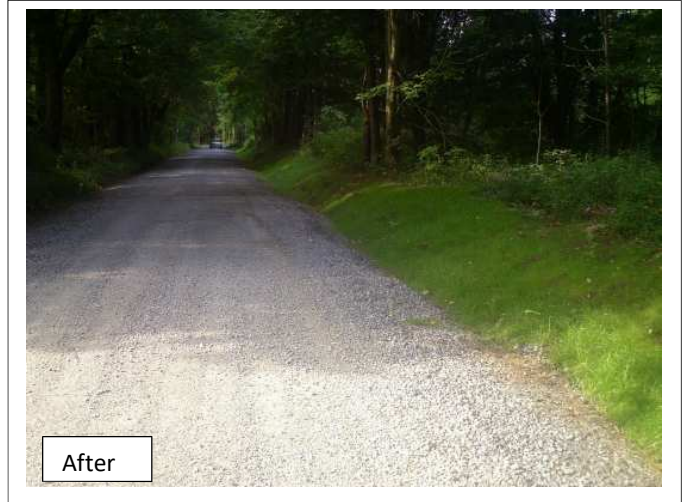
Problem: A roadside spring saturated the ditch and road base. The water carried sediment and road material into an existing inlet box, causing the inlet box and pipe to plug and fail. The water also caused the road bank to erode.

Solution: The area surrounding the existing spring was stabilized with stone. A storm drain was installed to carry the spring water to the existing inlet box. The road banks were graded and seeded to stabilize them.
