Bell Township – Beacon Road Project

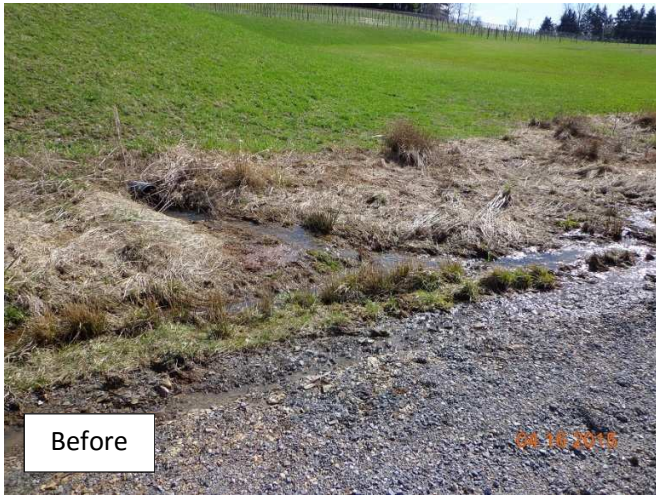
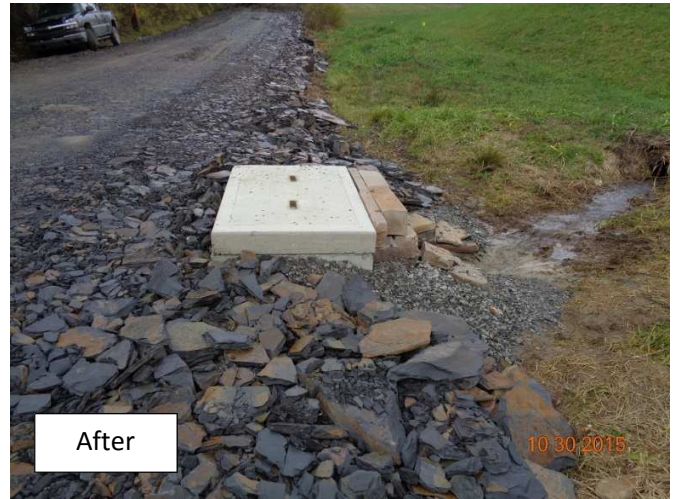
Problem: Ponds on each side of the Township Road were discharging onto the road, saturating ditches and the road base. The road was entrenched, acting like a ditch, picking up water from the top of the hill.

Solution: A cross pipe was installed at the top of the hill to divert runoff before it could negatively impact the road. An inlet box was installed to collect the pond discharge water and transport it under the road base through a newly installed storm pipe. Underdrains were installed on both sides of road. The road base was built up an average of 3 feet to promote sheet flow into vegetated areas.
