# Ringgold Township – Alcorn Road Project

This is a Low Volume Road (LVR) Project.

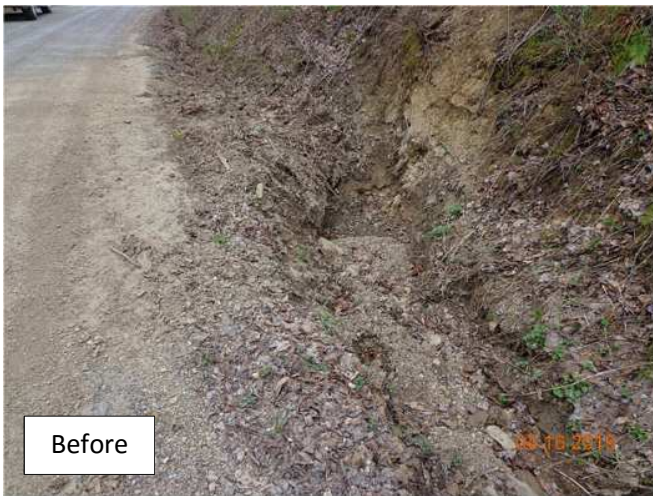
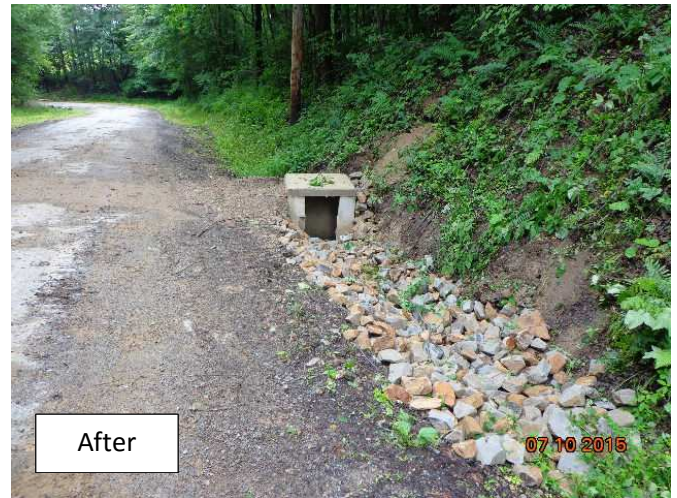
**Problem:** Excessive stormwater was running down the long, sloping road. Ditches were eroding and overflowing, existing cross pipes were not sufficient. The runoff was concentrated to one area, causing severe erosion.

**Solution:** Existing cross pipes were replaced with larger ones. Inlet boxes were installed to catch the water and help hold the banks. Seven additional cross pipes were installed. Improved berms enabled the water to sheet flow off the road into vegetated areas. The severely eroded area was stabilized with #4 and R5 stone, helping to clean and slow down the water.
