Young Township – Beyer Avenue Extension

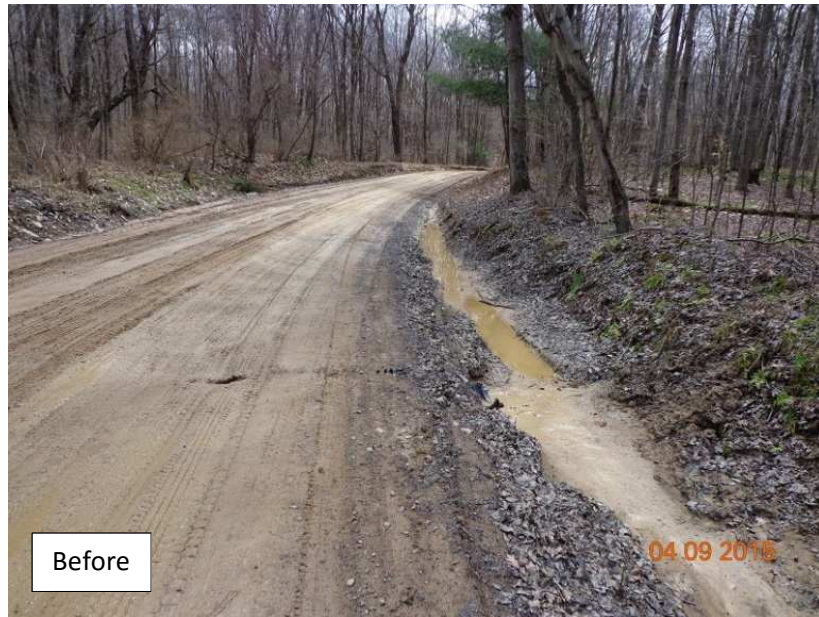
Problem: Due to wetlands on both sides of the road and poor drainage, the road base was saturated. An existing cross pipe was plugged and crushed.

Solution: The existing cross pipe was replaced, two French Mattresses, 155 feet of underdrain, and 3 feet of road fill were installed to greatly improve drainage.
