Polk Township – Dixon Road

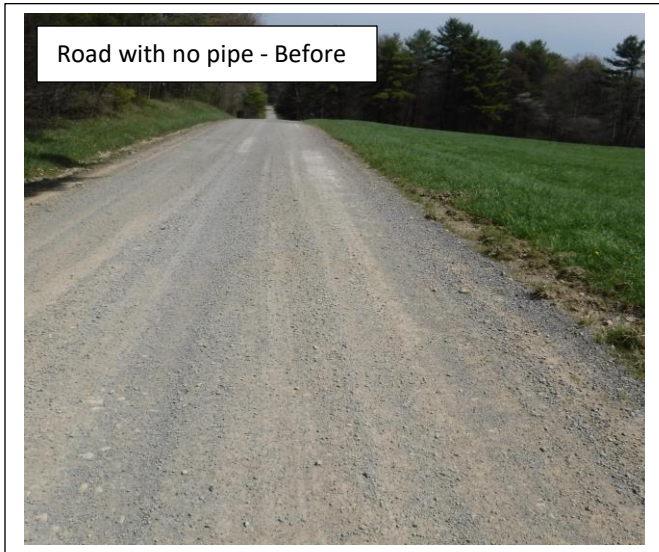
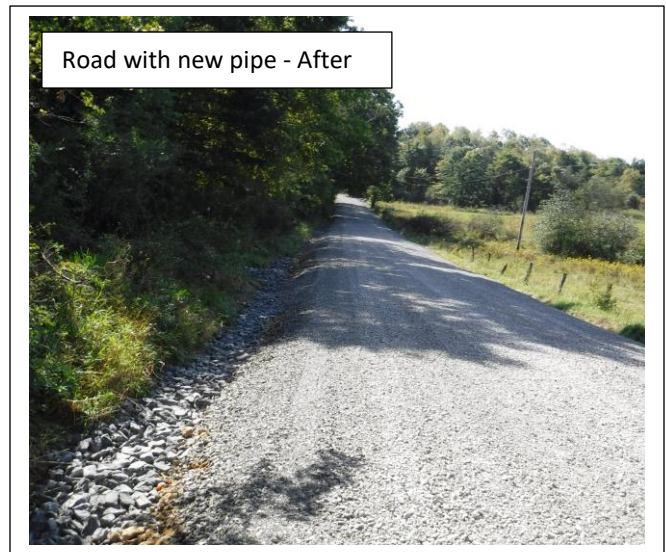
Problem: An entrenched road down a steep grade had excessive runoff on both sides during rain events. Additional runoff entered the roadway from an adjacent access road. 2 existing cross pipes discharged at the same location.

Solution: Installation of a new 18” cross pipe at the midpoint of the steep grade, which discharged to a well vegetated area. The existing 15” pipe was replaced with a 2’ pipe adequately convey the runoff. Pipe discharges were relocated to separate outlets prior to reaching the nearby stream. Head and end walls were installed on all pipes.

Additional grade breaks were installed on the adjacent access road to divert runoff into the woods prior to reaching the Township Road.

The road base was built up 3’ to encourage sheet flow.
