# Porter Township – Huber Road

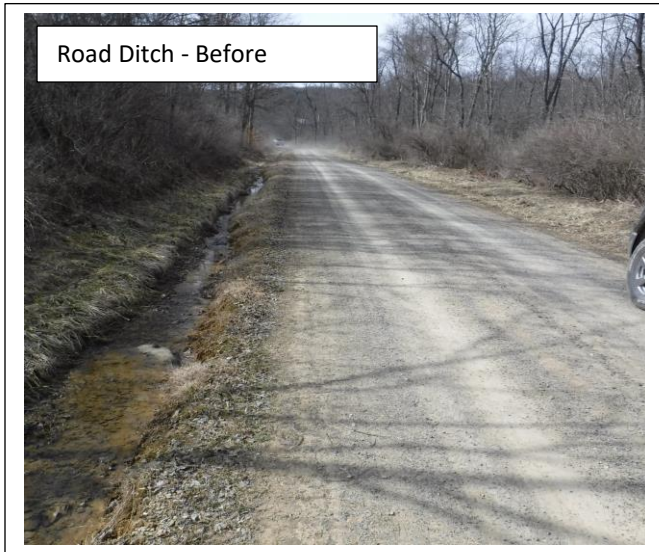
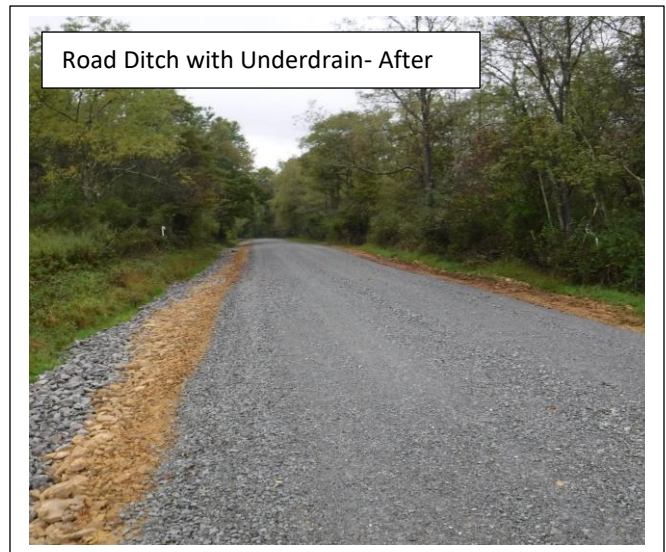
**Problem:** Lack of adequate cross pipes and saturated road ditches cause the road to become soft.

**Solution:** Replaced an inadequate 12” cross pipe with an 18” cross pipe; replaced another existing 15” cross pipe with a 2’ squash pipe.

Installation of 3 additional 18” cross pipes.

Head and end walls were installed on each pipe and stone filters were installed at each outlet.

Installation of 619’ of 6” underdrain.

The road was built up 1’ to encourage sheet flow.

Disturbed areas were seeded and mulched.
