Barnett Township – Songer Road

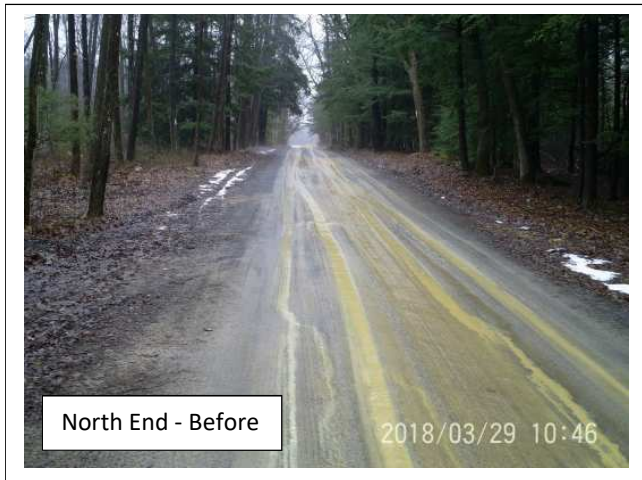
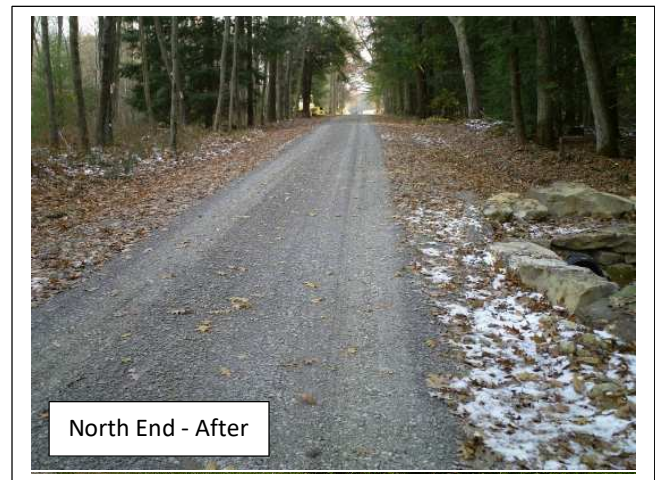
Problem: There was a roadside spring running along the road. The existing underdrain was plugged. Offsite runoff was entering the roadway from a camp's driveway. The road grade was lower than the surrounding area. The road was acting as a ditch and was carrying sediment directly to the stream. A field drain discharged water along the road.

Solution: The existing underdrain was replaced. A pipe was installed to collect the water from the roadside spring and field drain and keep it free from sediment. A stone filter was installed at the outlet to dissipate the water before discharging directly to the stream. Geotextile fabric was used to support the road base. The grade of the road was built up 1 ½ feet to encourage sheet flow.
