Barnett Township – Jacks Hollow Road

Forest County

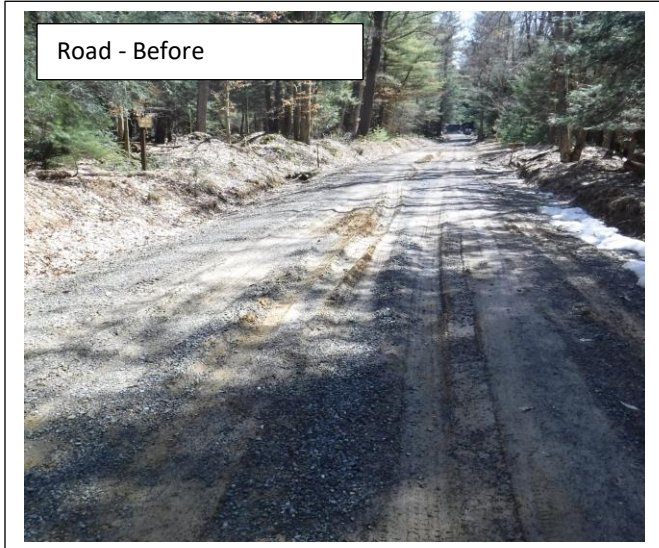
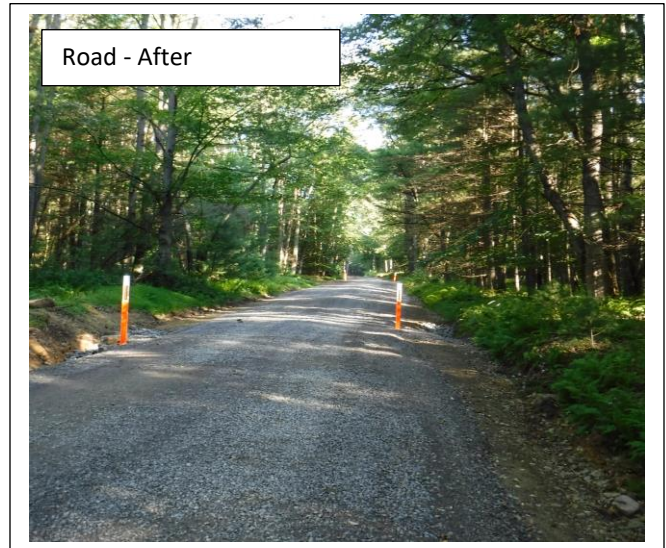
Problem: The road base had deteriorated and was very unstable. The entrenched roadway was discharging sediment laden runoff directly to the nearby stream. The only existing cross pipe was inadequate.

Solution: An average of 2' of fill was added to raise the road profile and encourage sheet flow. 1537 square yards of geotextile fabric was installed prior to the fill placement to provide additional base stability. The undersized, existing cross pipe was replaced with an 18" pipe, along with a stone-lined waterway at the outlet to further filter the discharge. An 18' through-the-bank pipe and 2 turn-outs were installed to help direct runoff to well vegetated areas. All disturbed areas were seeded and mulched.
