Howe Township – Job Corps Road

Forest County

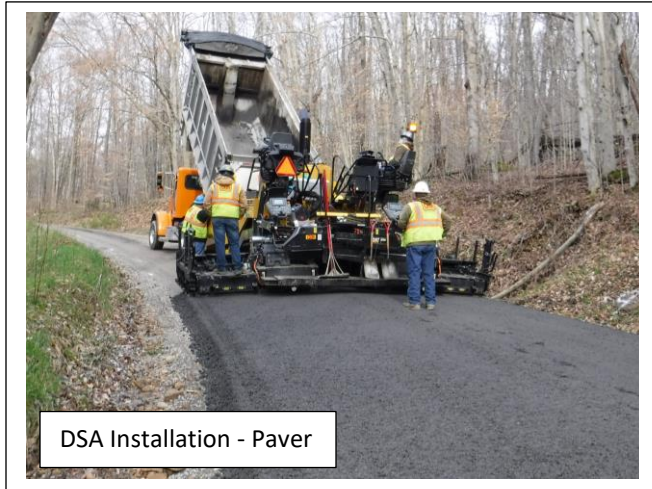
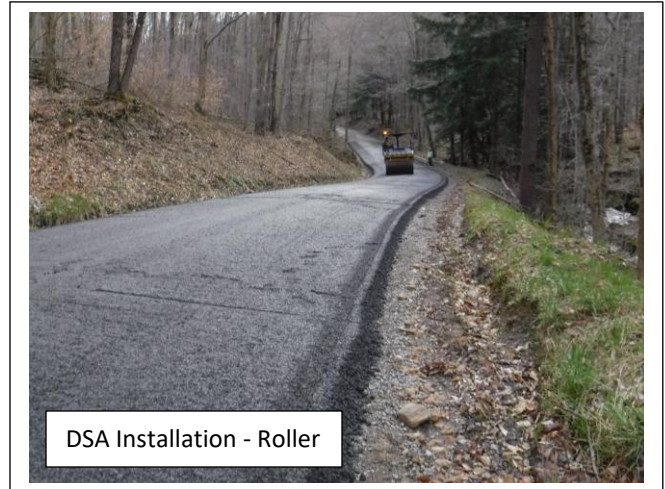
Problem: Water was running down steep roadside ditches for long distances, causing erosion. There were not enough crosspipes. The road surface was washboarding from the steepness of the hill and poor surface material.

Solution: Crosspipes and underdrains were added where needed to disperse runoff. 5,616 square yards of DSA were placed on the road surface to help stabilize it.
