Warsaw Township – Hazen Richardsville Road Low Volume Road (LVR) Project

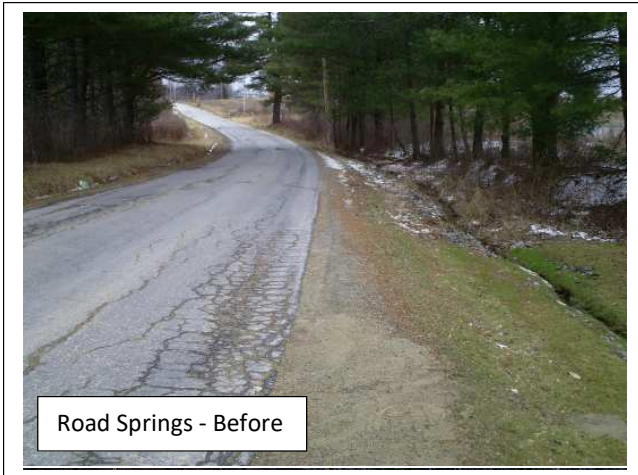
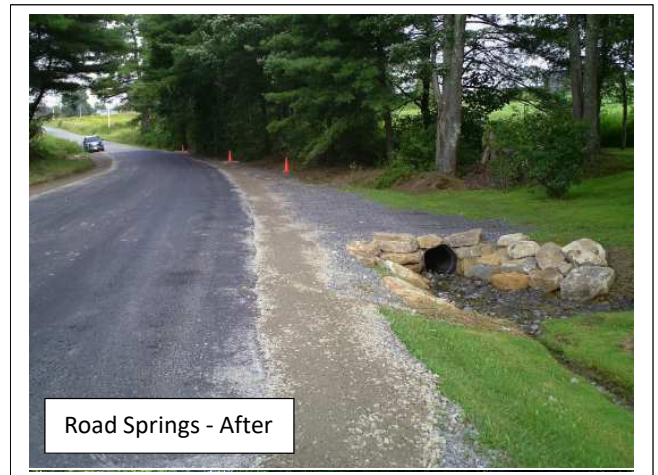
Problem: The road base was saturated by water coming from two road side springs and a pond located directly along the road. There was flowing water in the existing ditch.

Solution: A 10" underdrain with inlet boxes was installed to collect water from the springs. A French mattress was installed to help stabilize the road base. A headwall and endwall were installed on an existing cross pipe. The road surface above the French mattress was paved and a turnout was installed.
